ON THE PLASMA-ASSISTED MODIFICATIONS OF PRE-TEXTURED SURFACES:
SHALLOW DEPTH NITRIDING IN CAST IRON, TOPOGRAPHY AND
INSTRUMENTED SCLEROMETRY TEST RESPONSE

Thesis submitted to the Polytechnic School of the University of São Paulo, in conformity with the requirements for the degree of Doctor of Science.

Metallurgical and Materials Engineering

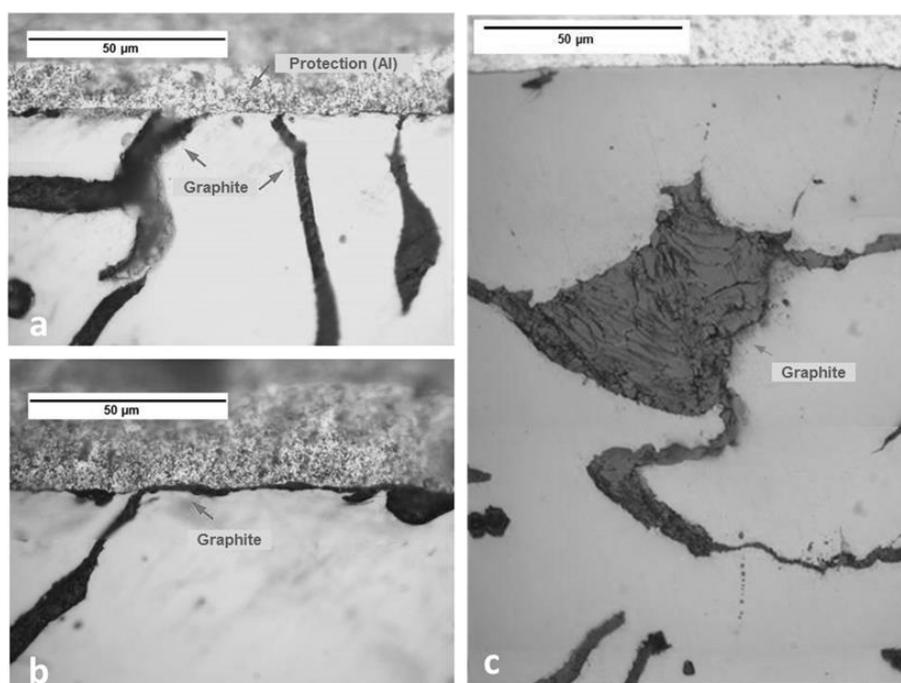
Figure 2: Graphite geometry and position found in the cylinder bore surface varies in thickness and size. The flake orientation will affect the graphite position in a surface of interest [55].

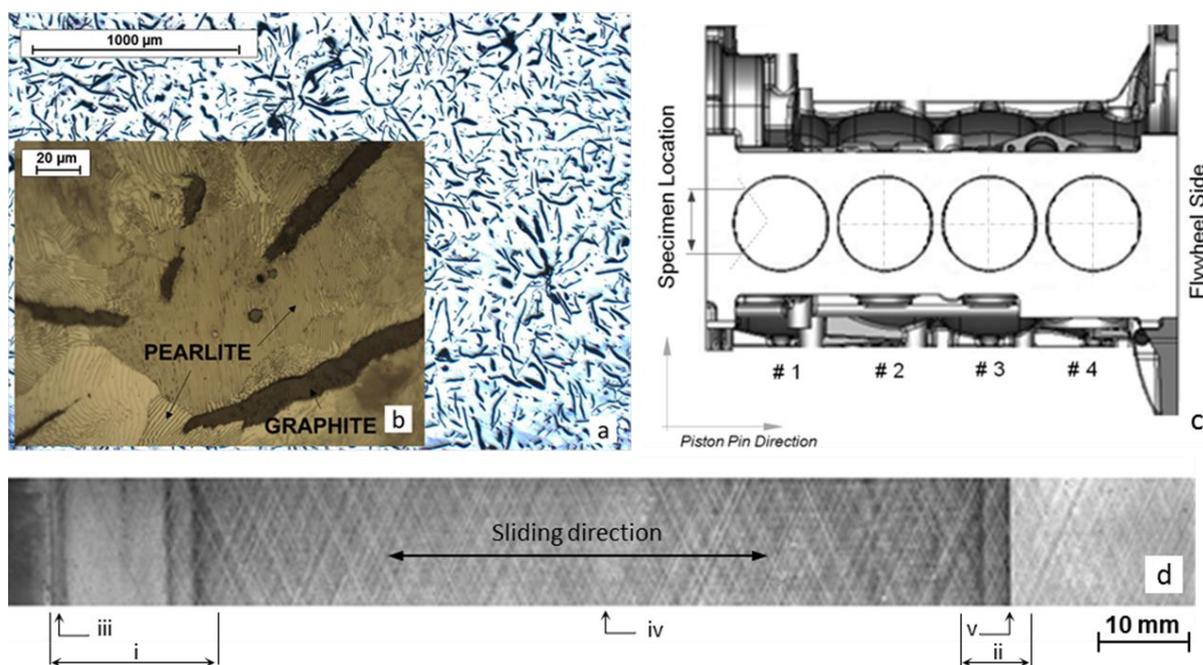
Figure 3: Schematic of cylinder bore material microstructure and characterization specimens location. a) Optical micrograph from the cylinder block material, as polished, not etched. Flake graphite is revealed. b) Optical micrograph illustrating the matrix of pearlite. (2% Nital solution). c) Scheme of cylinder block specimen location. d) SEM analysis location scheme (see Table 2). The regions of localized wear were identified by the profilometer analysis, which guided the SEM analysis.

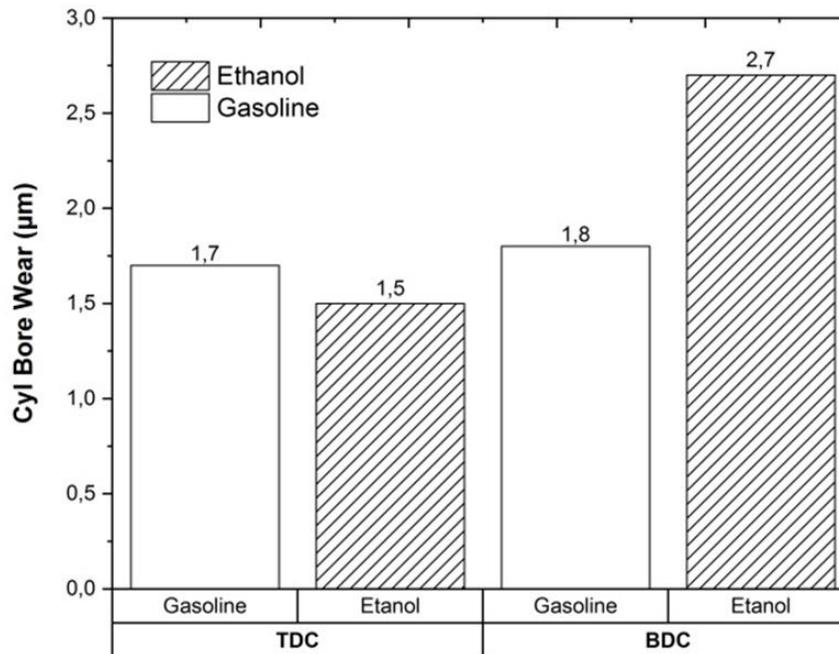
Figure 4: Cylinder Bore localized wear in the TDC and BDC regions. At end-of-test with gasoline and ethanol. Results are based on 2-D profilometer analysis reported in [58].

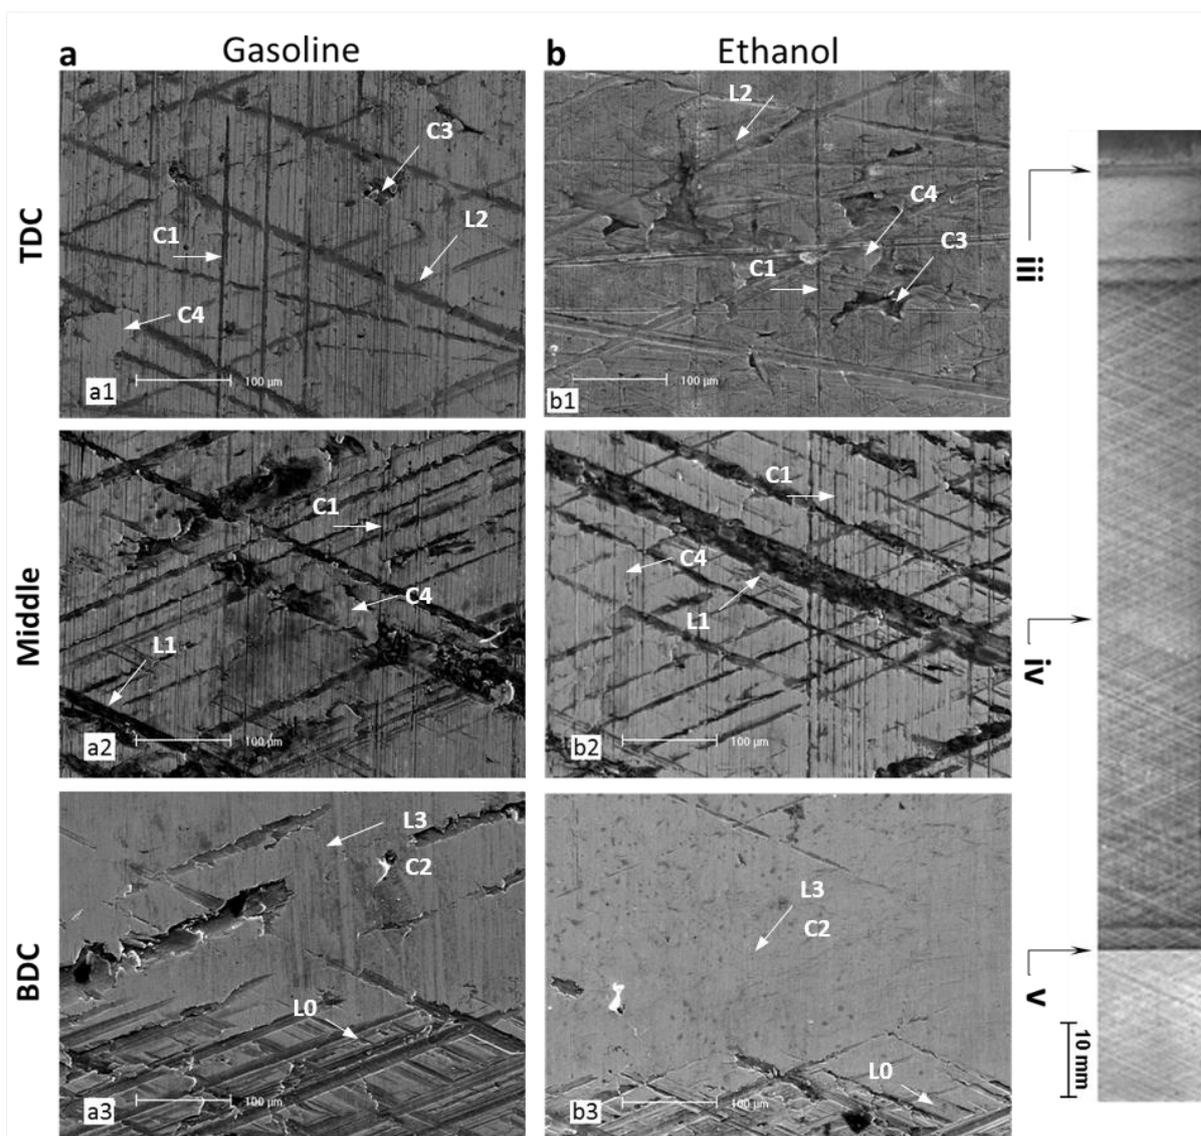
Figure 5: Bore surface SEM Analysis. At end-of-test with (a) gasoline and (b) ethanol.

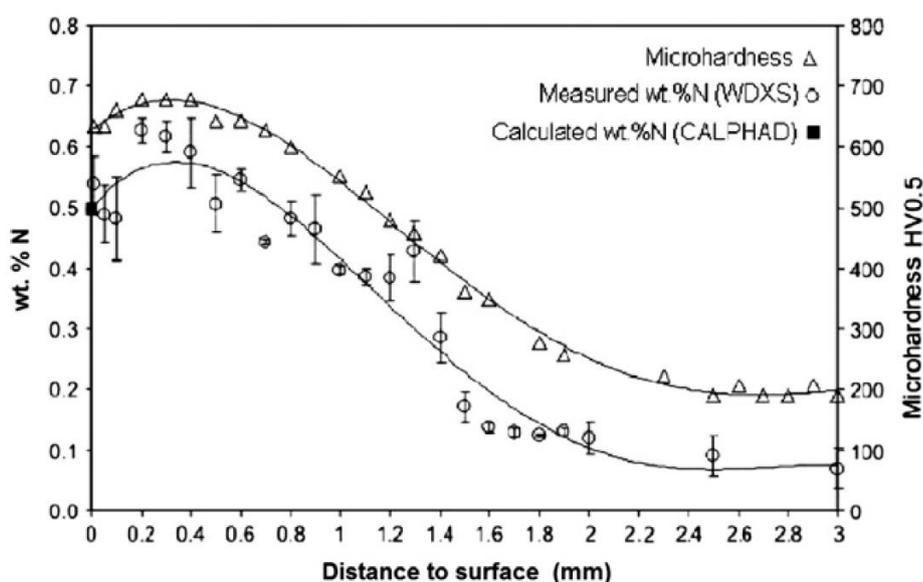
Figure 9: N distribution and microhardness of AISI410S steel nitrided at 800 °C - 6h [68].

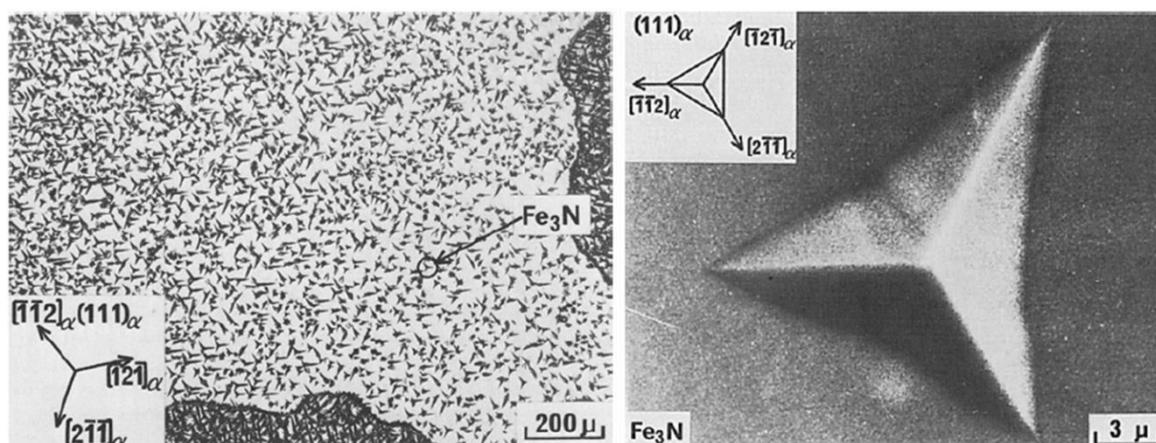
Figure 10: a) Photomicrograph of Fe_3N on the surface of $(111)\alpha$ grain after nitriding in gas (NH_3/H_2) process. b) SEM micrograph showing Fe_3N on the surface of $(111)\alpha$ grain after nitriding in gas (NH_3/H_2) process [69].

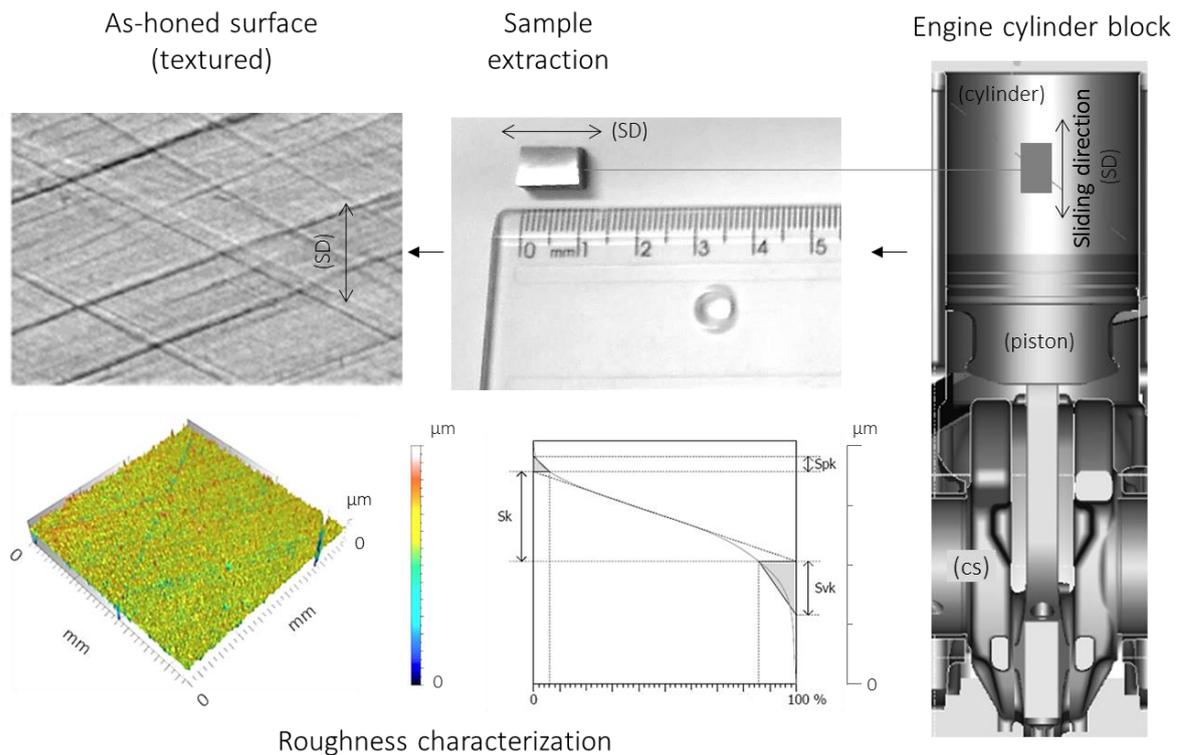
Figure 20: Specimen preparation scheme. Case-study: as-honed surface. Section on the right illustrates the cylinder block application in the engine, including the crankshaft (cs) and piston, whose sliding direction (SD) is indicated.

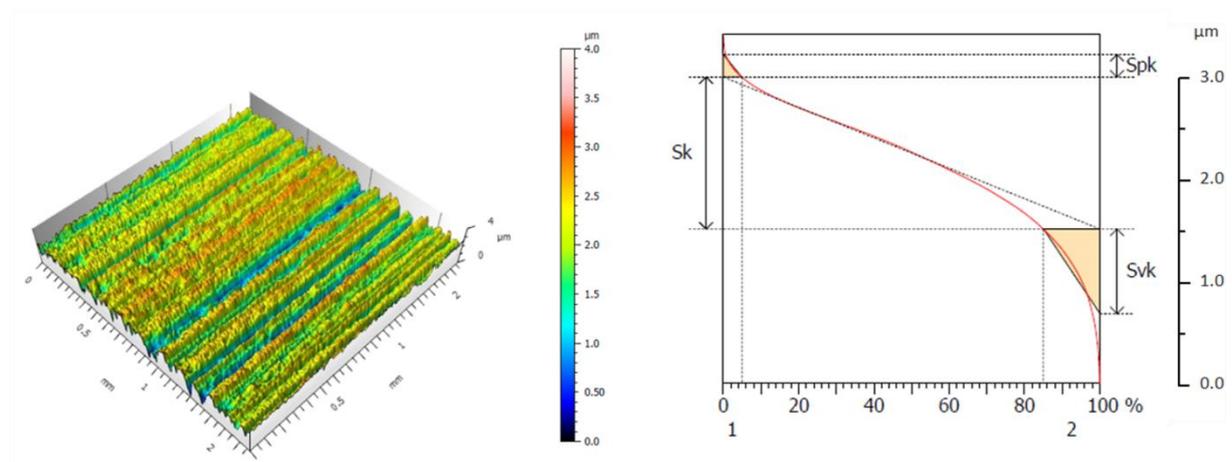
Figure 23: 3-D profile and the respective material ratio curve. In-lab textured flat specimens. The roughness parameters identified by S_k , S_{pk} , S_{vk} are extracted from the curve.

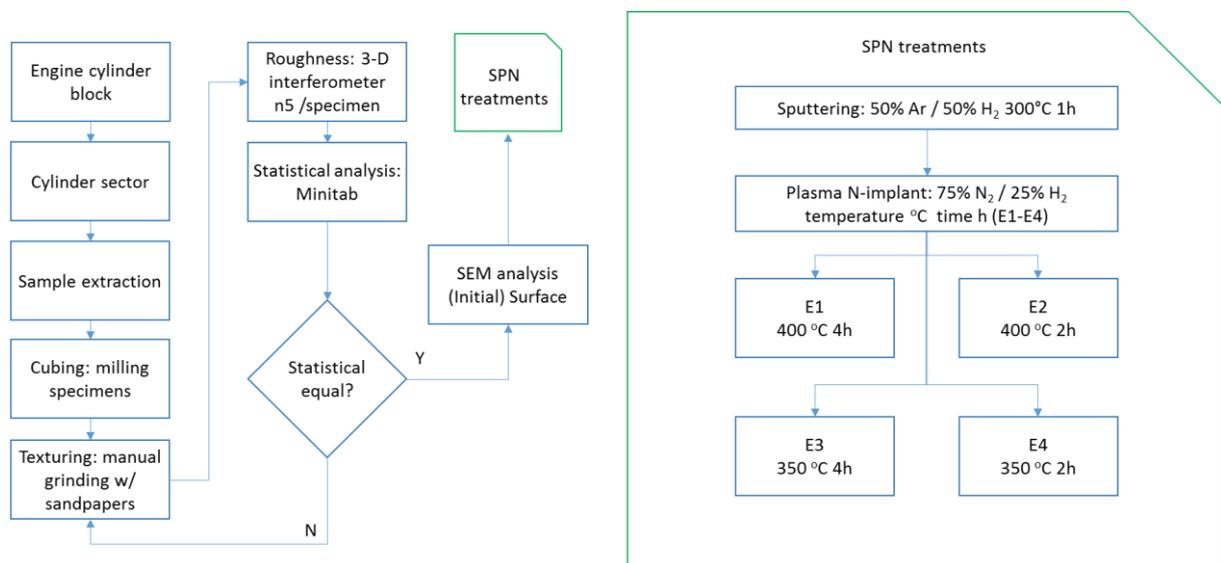
Figure 25: Flowchart of the specimen preparation and SPN treatments. In-lab textured flat specimens.

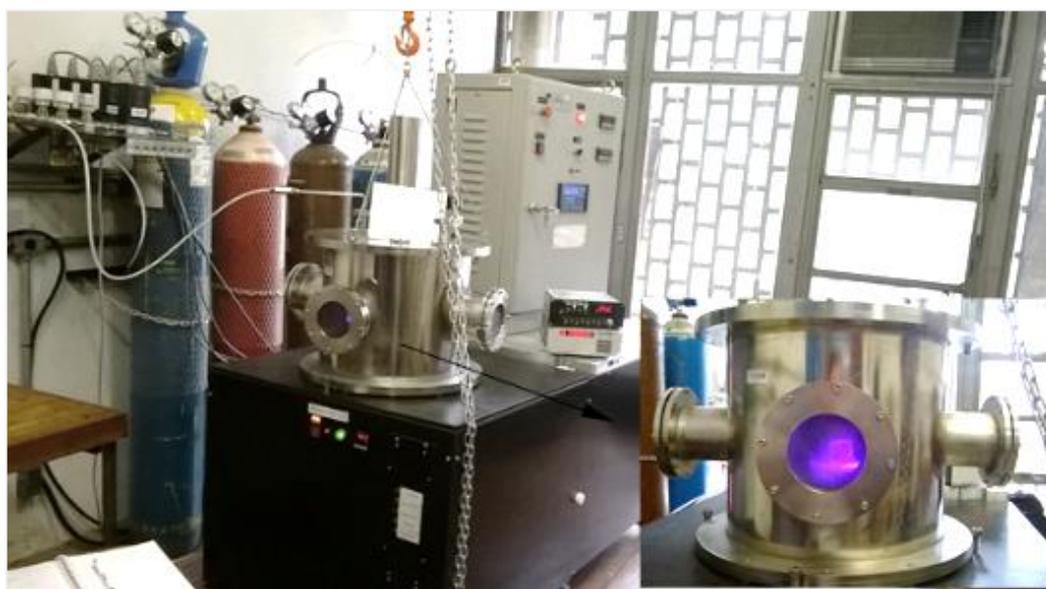
Figure 26: The plasma treatment unit of Plasma Laboratory of the Department of Metallurgical and Materials Engineering of the University of São Paulo.

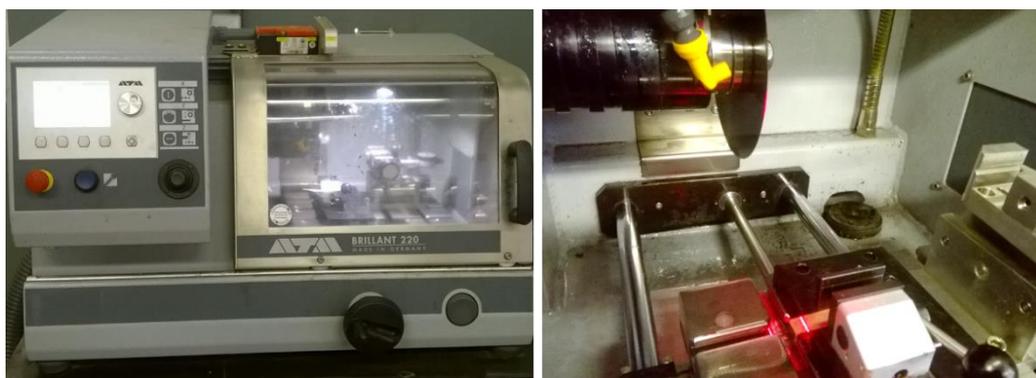
Figure 28: Precision abrasive cutting machine. Detail: section location guided by laser.

Precision abrasive cutting machine model ATM Brillant 220 was used (Figure 28) to obtain cross sections perpendicular to the textured surface with high level of reproducibility. The cross sections were hot compression-mounted in phenolic resin and ground using increasingly finer silicon carbide (SiC) papers, from grit size 180 down to 1200, on an automatic polisher, and then polished using standard polishing clothes and polycrystalline diamond paste of reducing diamond particle sizes from 9 μm to 3 μm .

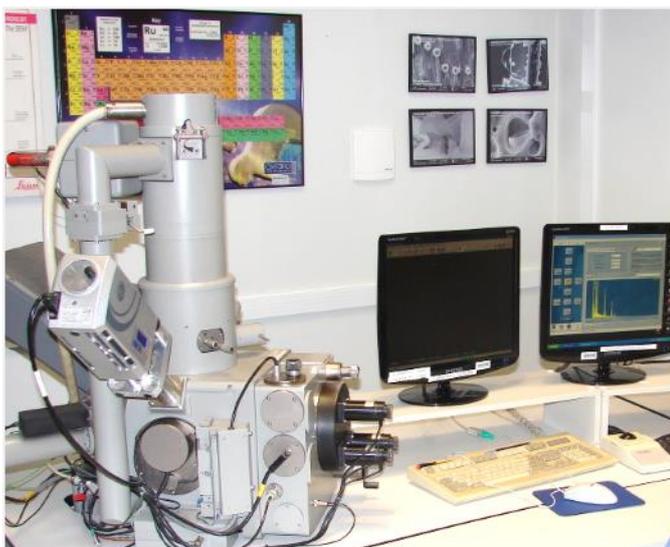
Figure 29: Oxford WDX600 spectrometer coupled to a Cambridge Stereoscan 440 scanning electron microscope of LCT-USP. Nitrogen was measured by using synthetic LSM60 crystal.

Similarly to previous works [67,68], the WDS analyses were carried out in an Oxford WDX600 spectrometer (Figure 29) with take-off angle of 35° , coupled to a Cambridge Stereoscan 440 scanning electron microscope equipped with a LaB_6 emission source operating at 10 or 12 kV. Nitrogen was measured by using synthetic LSM60 crystal.

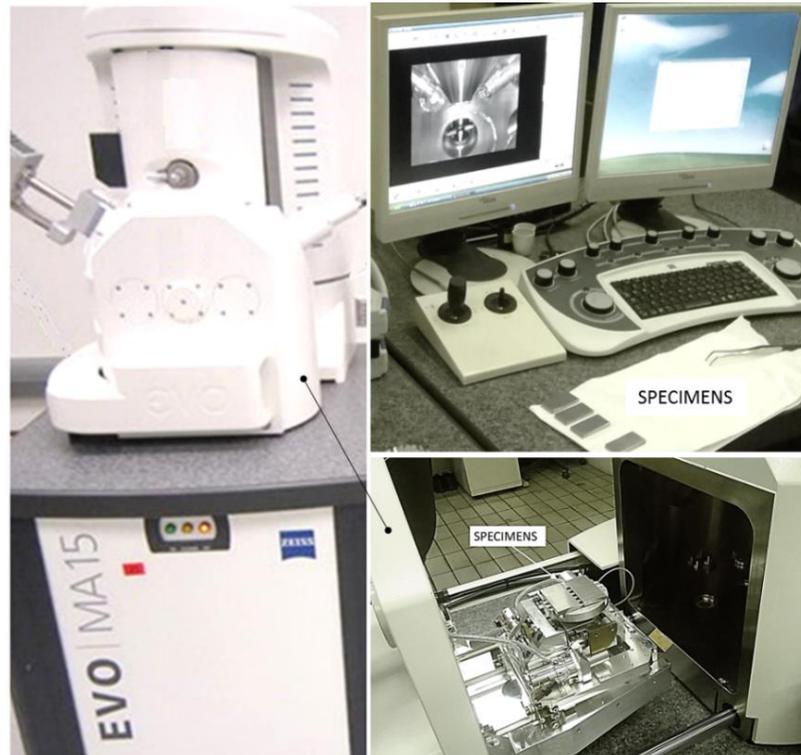
Figure 31: Scanning electron microscope model ZEISS-EVO-MA10.

An equipment model ZEISS-EVO-MA10 (Figure 31) was used to perform the SEM analysis, on the specimen surface. Aiming to identify any eventual after-treatment surface changes, a before/after analysis has been carried out. The specimens were ultrasonic cleaned in isopropyl alcohol for 30 minutes before the surface SEM measurements.

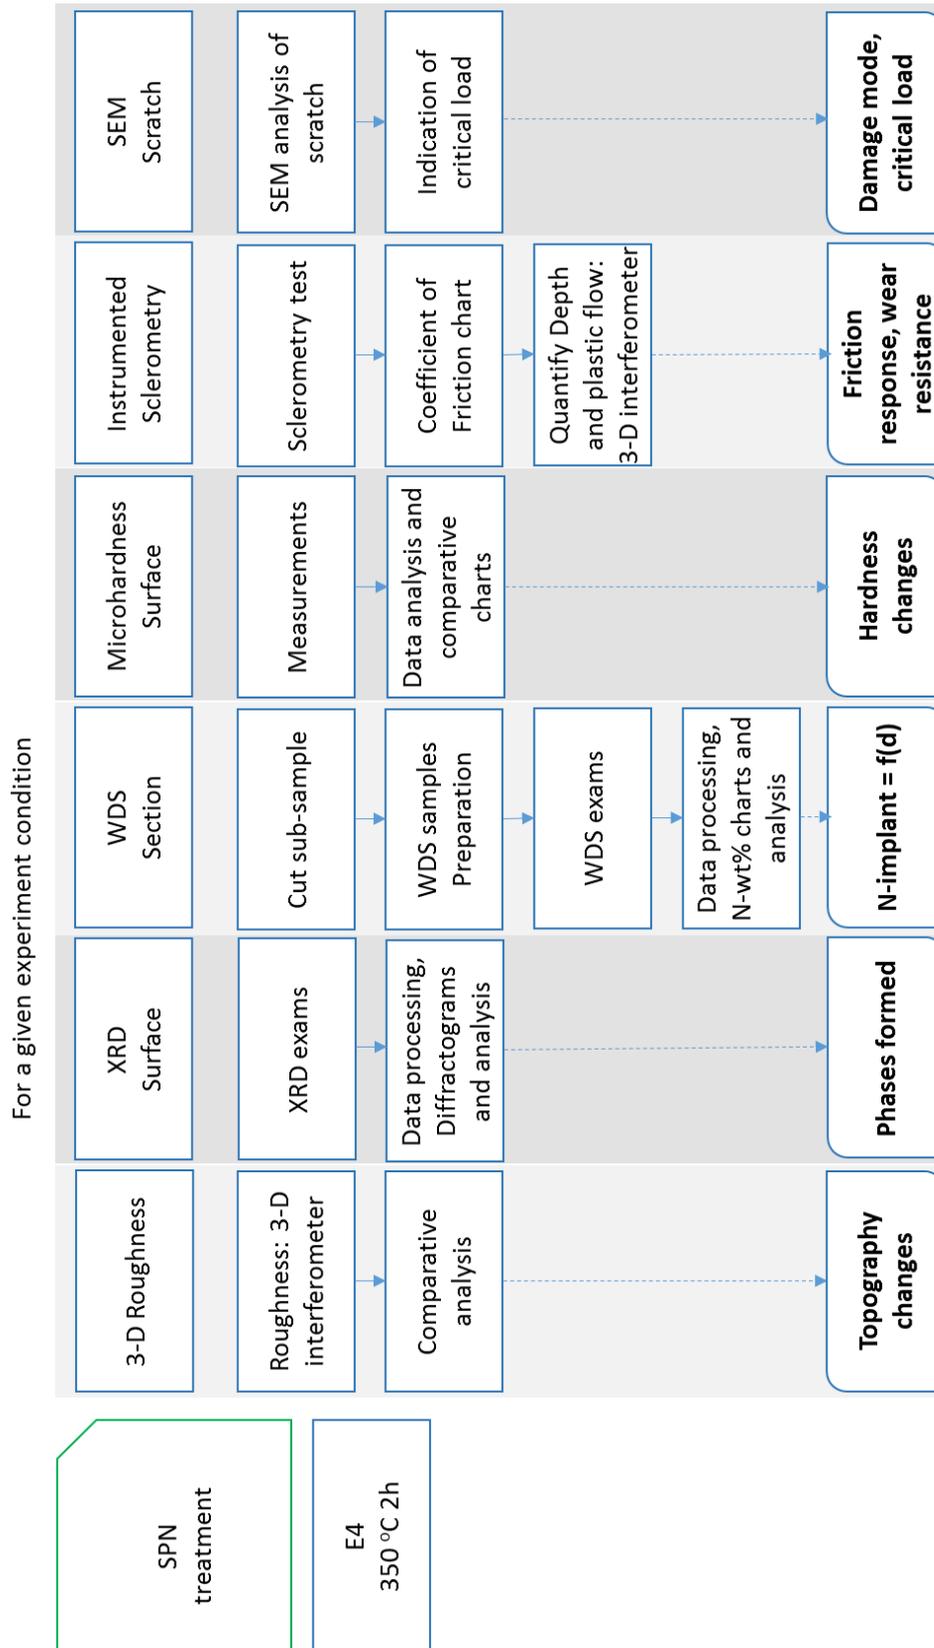
Figure 38: Flowchart of methods. Case-study: As-honed surface specimen.

Finally, the flowchart of methods of the in-lab textured flat and of the as-honed surface specimen (case-study), is shown in Figure 37 and Figure 38, respectively.

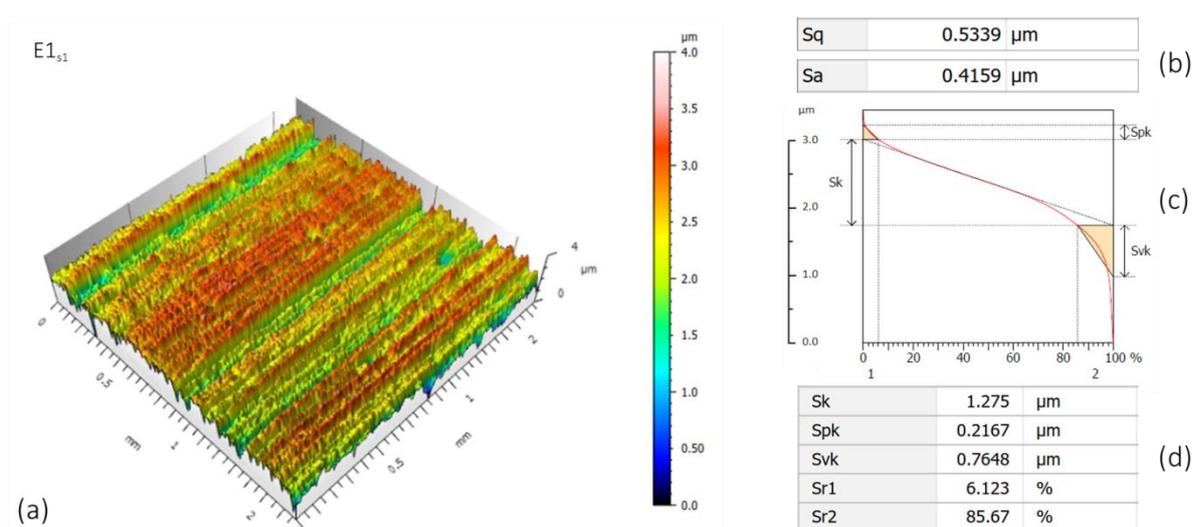
Figure 39: a) 3-D profile of the textured surface plane. The color scale indicates the resulting heights from valley to peak. b) Sq and Sa parameters results calculated by TalyMap 3-D software. c) Material ratio curve and respective Sk, Spk, Svk, Sr1, Sr2 parameters (d) extracted from the curve. In-lab textured flat specimen E1 in the initial condition (before SPN treatment).

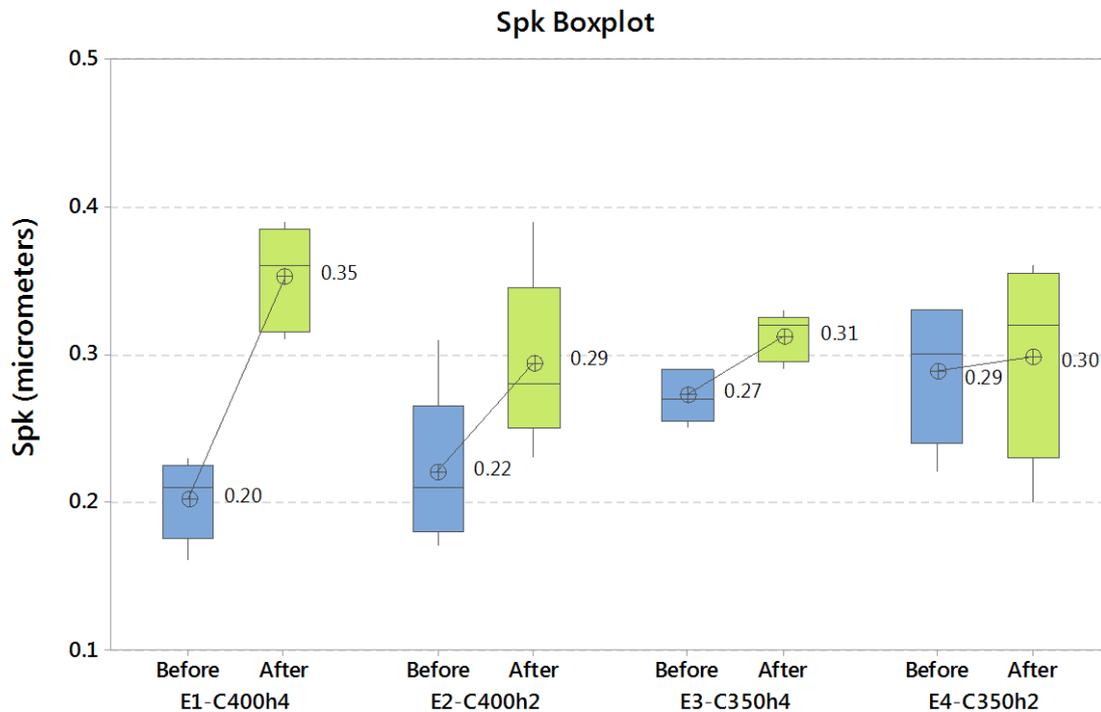
Figure 48: Boxplot of experiment results, before and after treatment. Spk roughness.

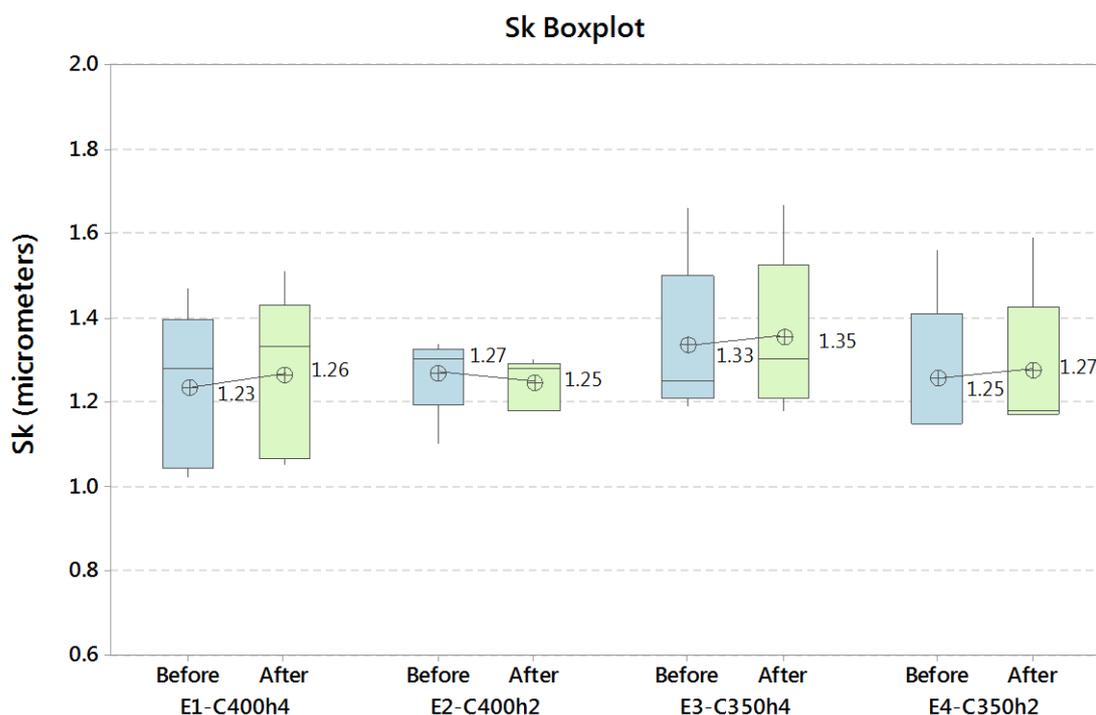
Figure 50: Boxplot of experiment results, before and after treatment. Sk roughness.

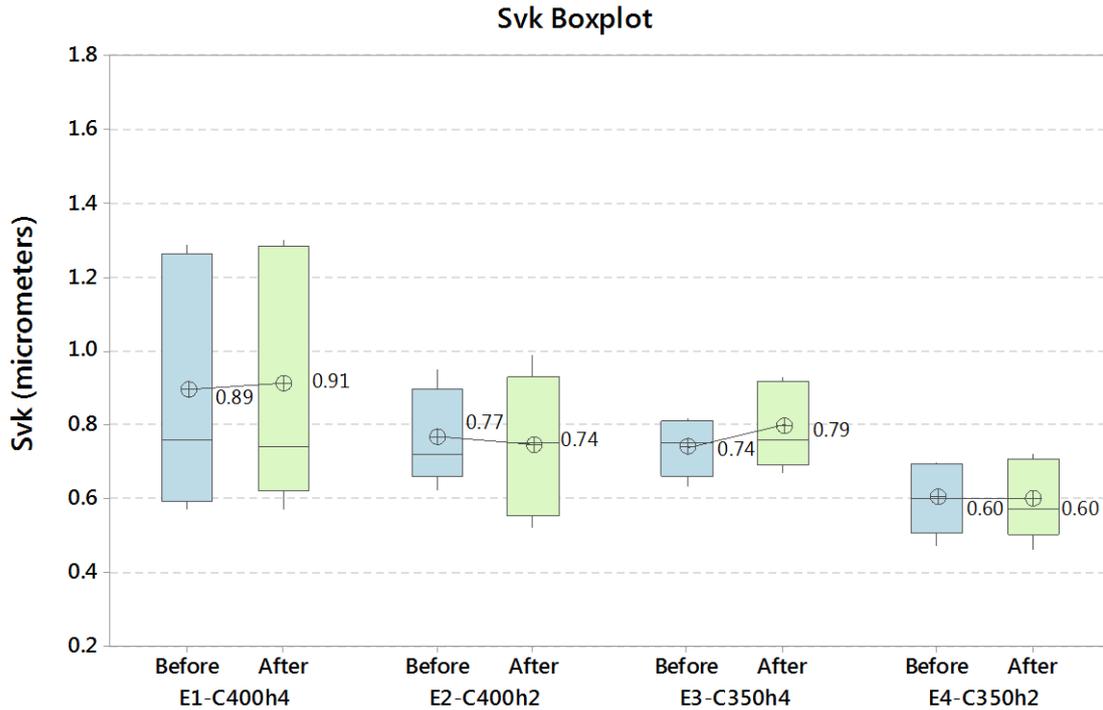
Figure 51: Boxplot of experiment results, before and after treatment. Svk roughness.

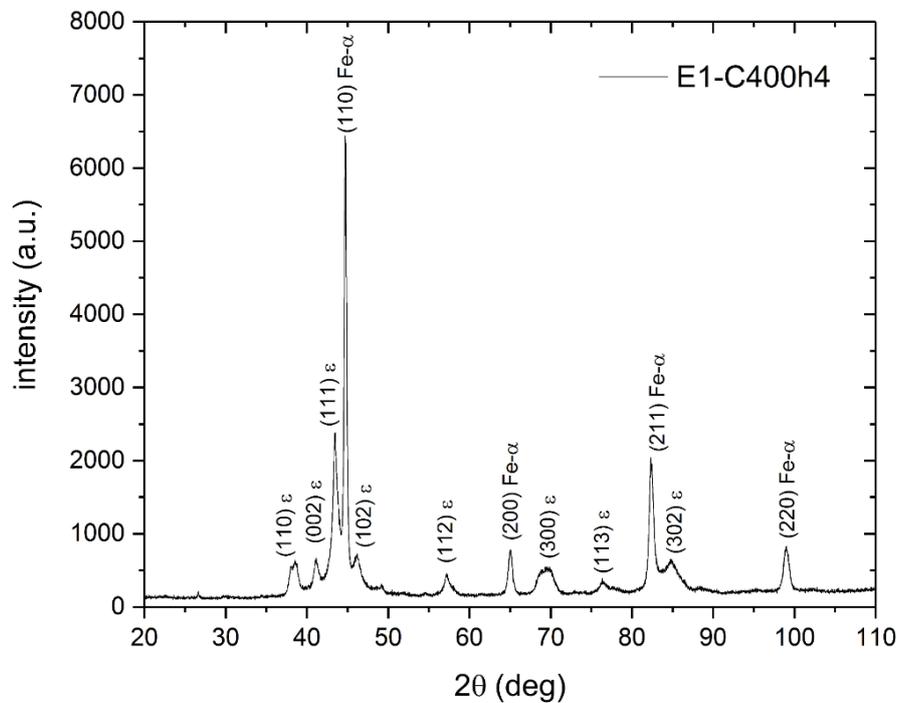
Figure 68: XRD diffractogram of the textured surface treated in the condition E1-C400h4.

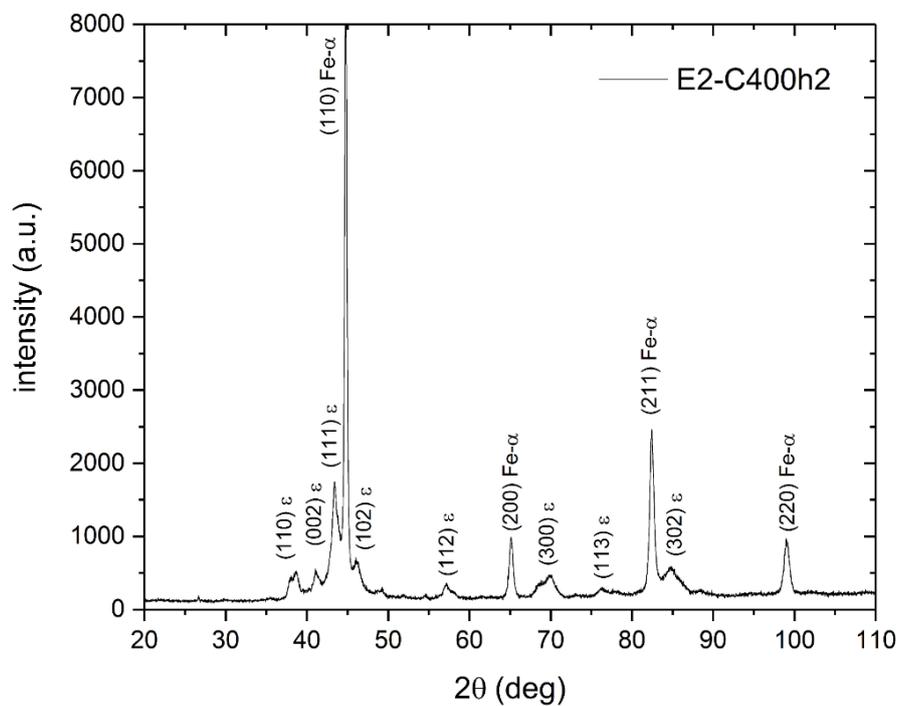
Figure 69: XRD diffractogram of the textured surface treated in condition E2-C400h2.

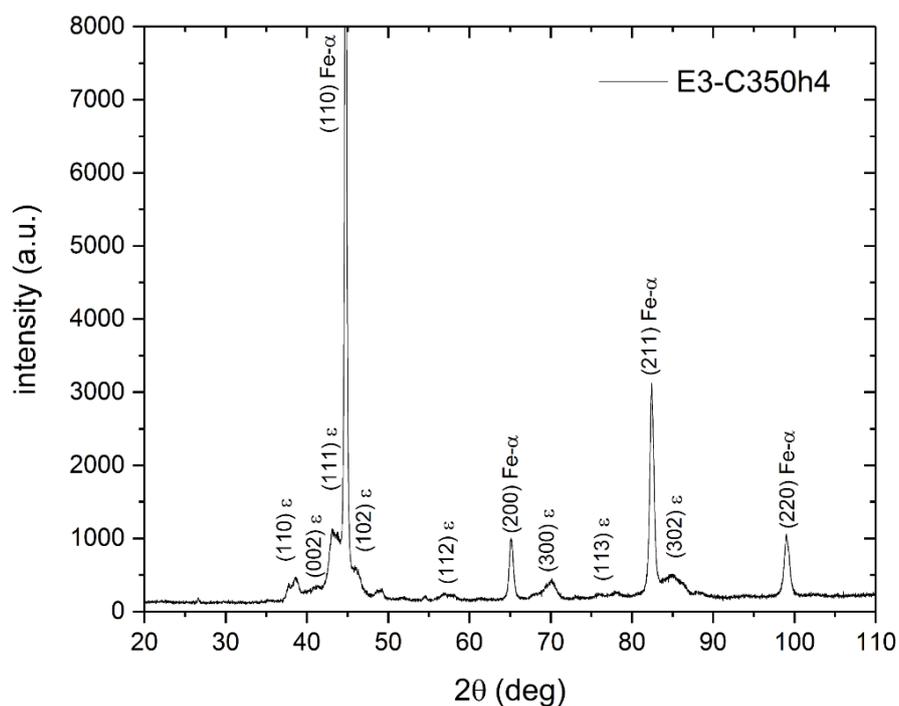
Figure 70: XRD diffractogram of the textured surface treated in condition E3-C350h4.

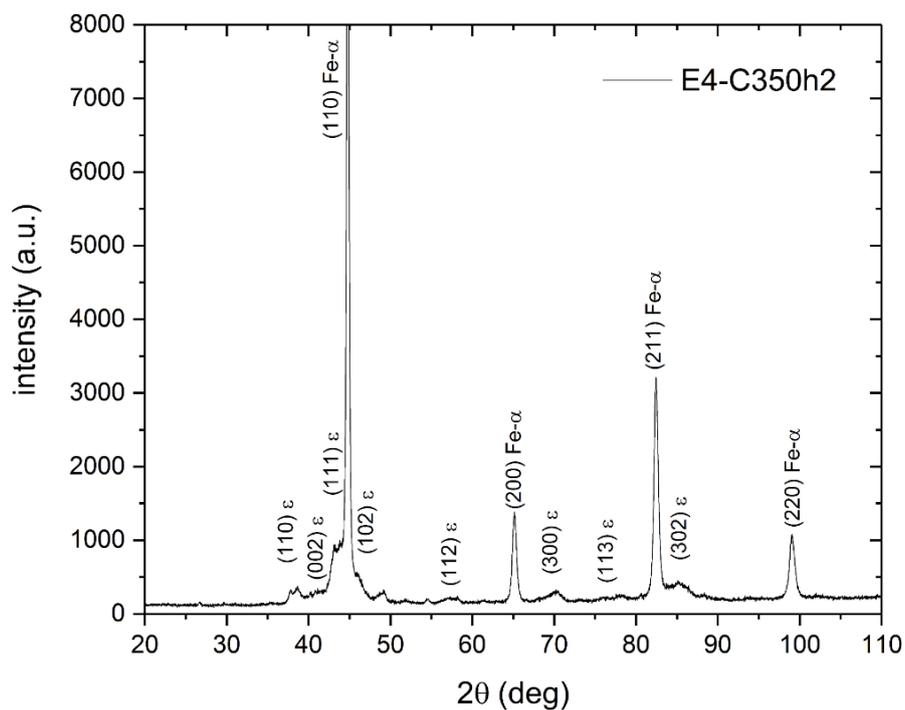
Figure 71: XRD diffractogram of the textured surface treated in condition E4-C350h2.

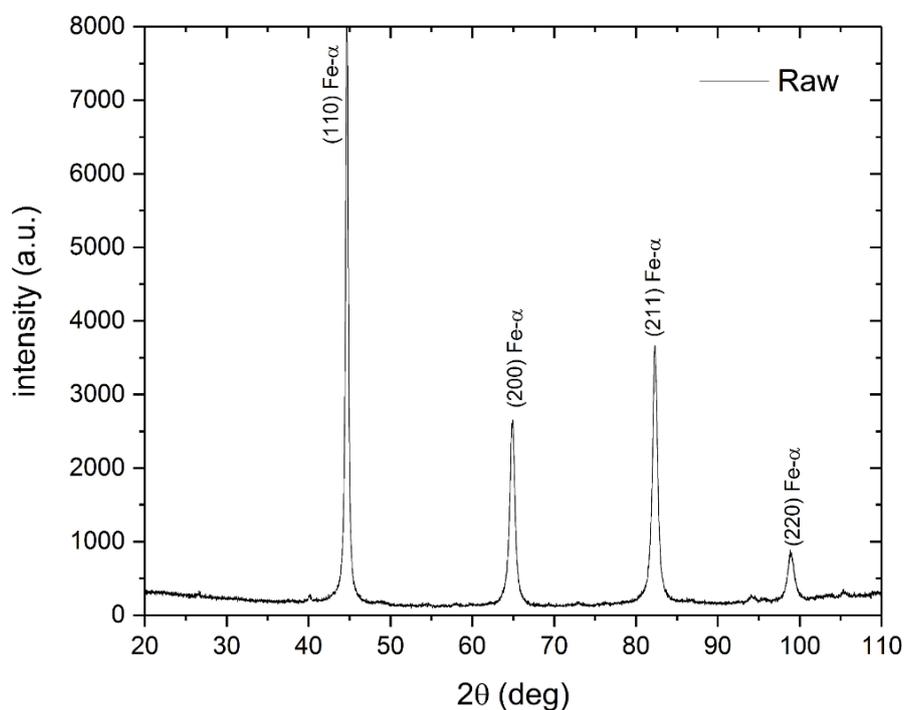
Figure 72: XRD diffractogram of the textured surface in condition Raw, before SPN (Baseline sample/material same as case-study).

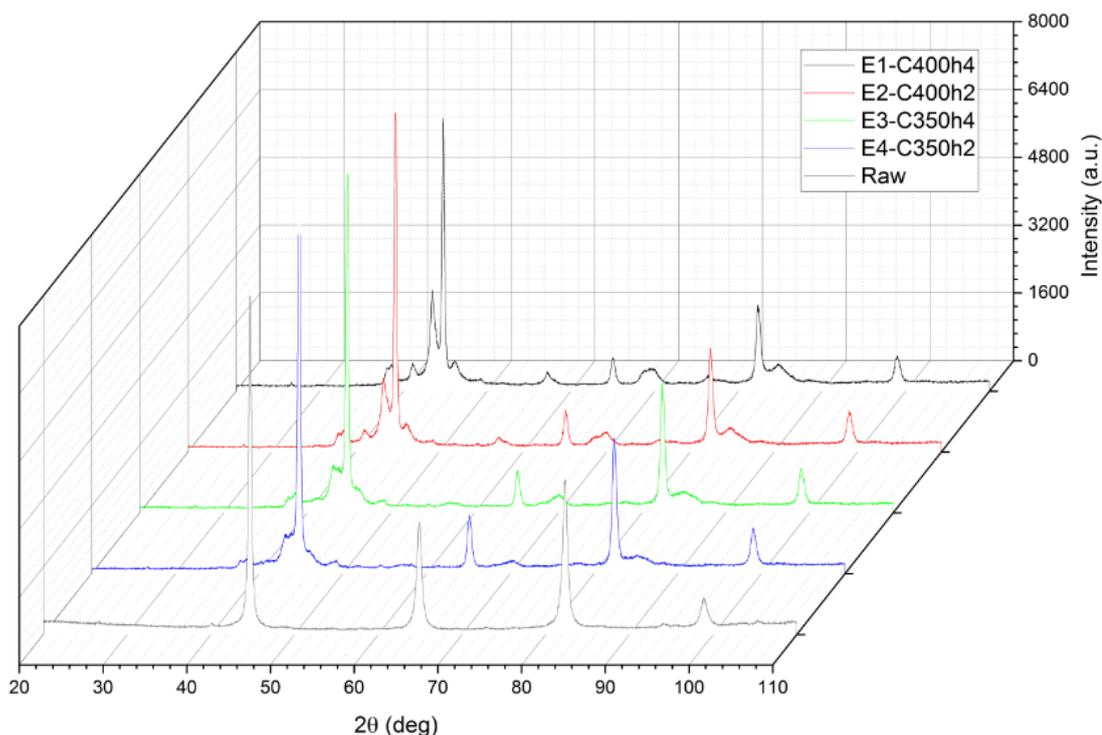
Figure 73: XRD combined 3-D diffractogram of the textured surface in the conditions E1-C400h4, E2-C400h2, E3-C350h4 and E4-C350h2 and Raw.

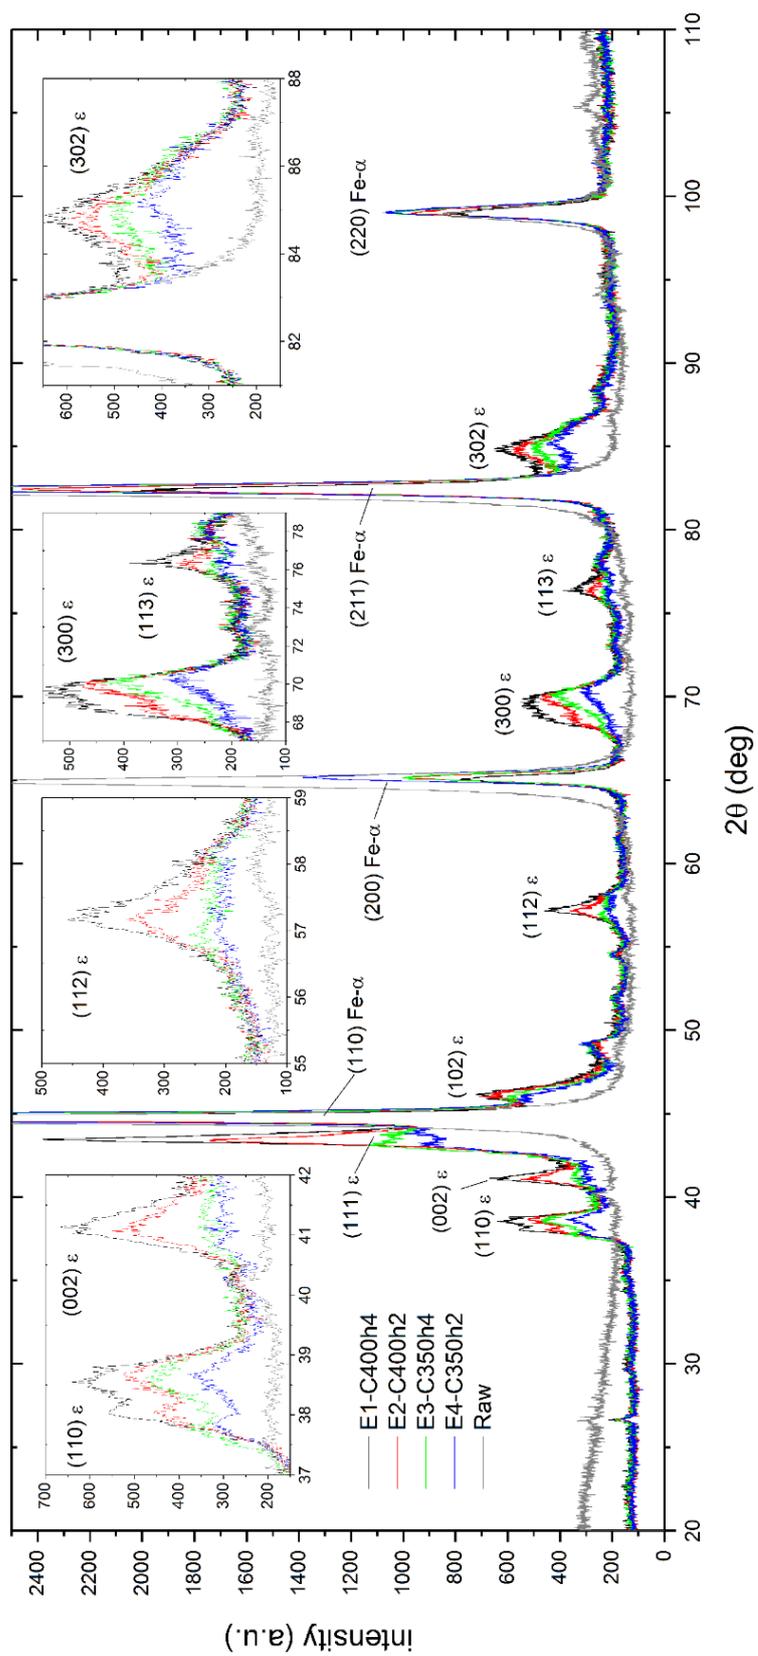
Figure 74: XRD combined diffractogram of the textured surface in the conditions E1-C400h4, E2-C400h2, E3-C350h4, E4-C350h2, and Raw.

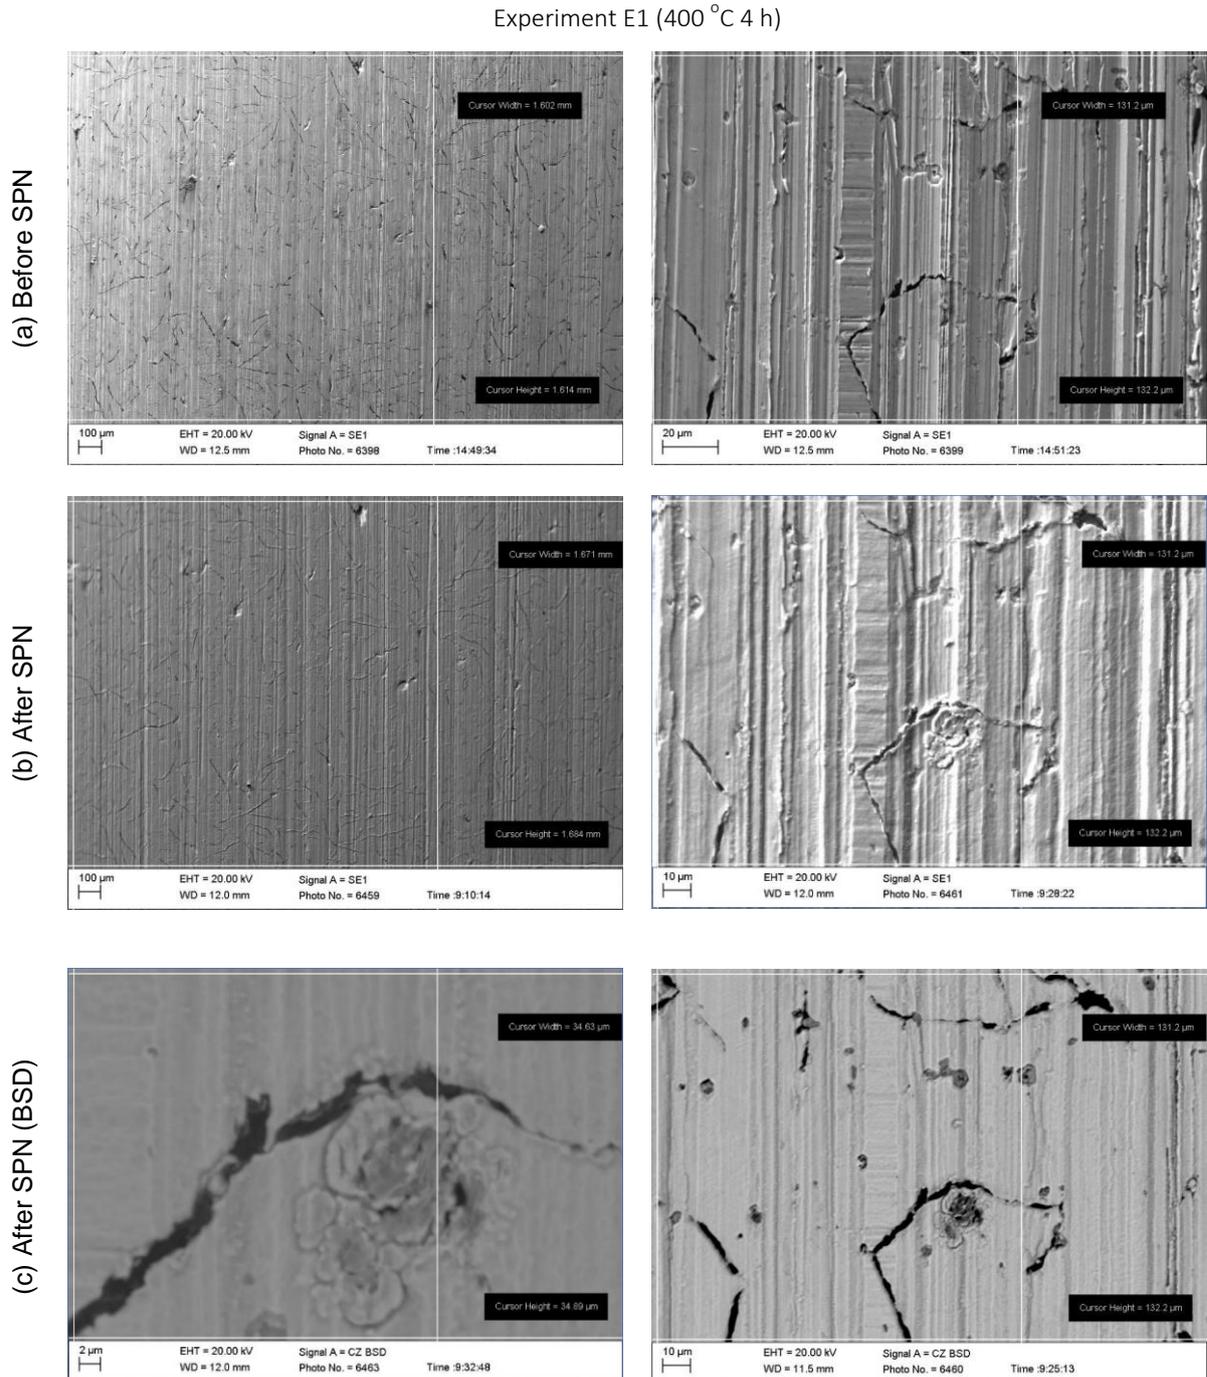
Figure 75: Experiment E1 (400 °C 4 h). Comparative Scanning Electronic Microscopy (SEM) images. Conditions (a) Before SPN, (b) After SPN - secondary electron analysis, and (c) After SPN - backscattered electron analysis.

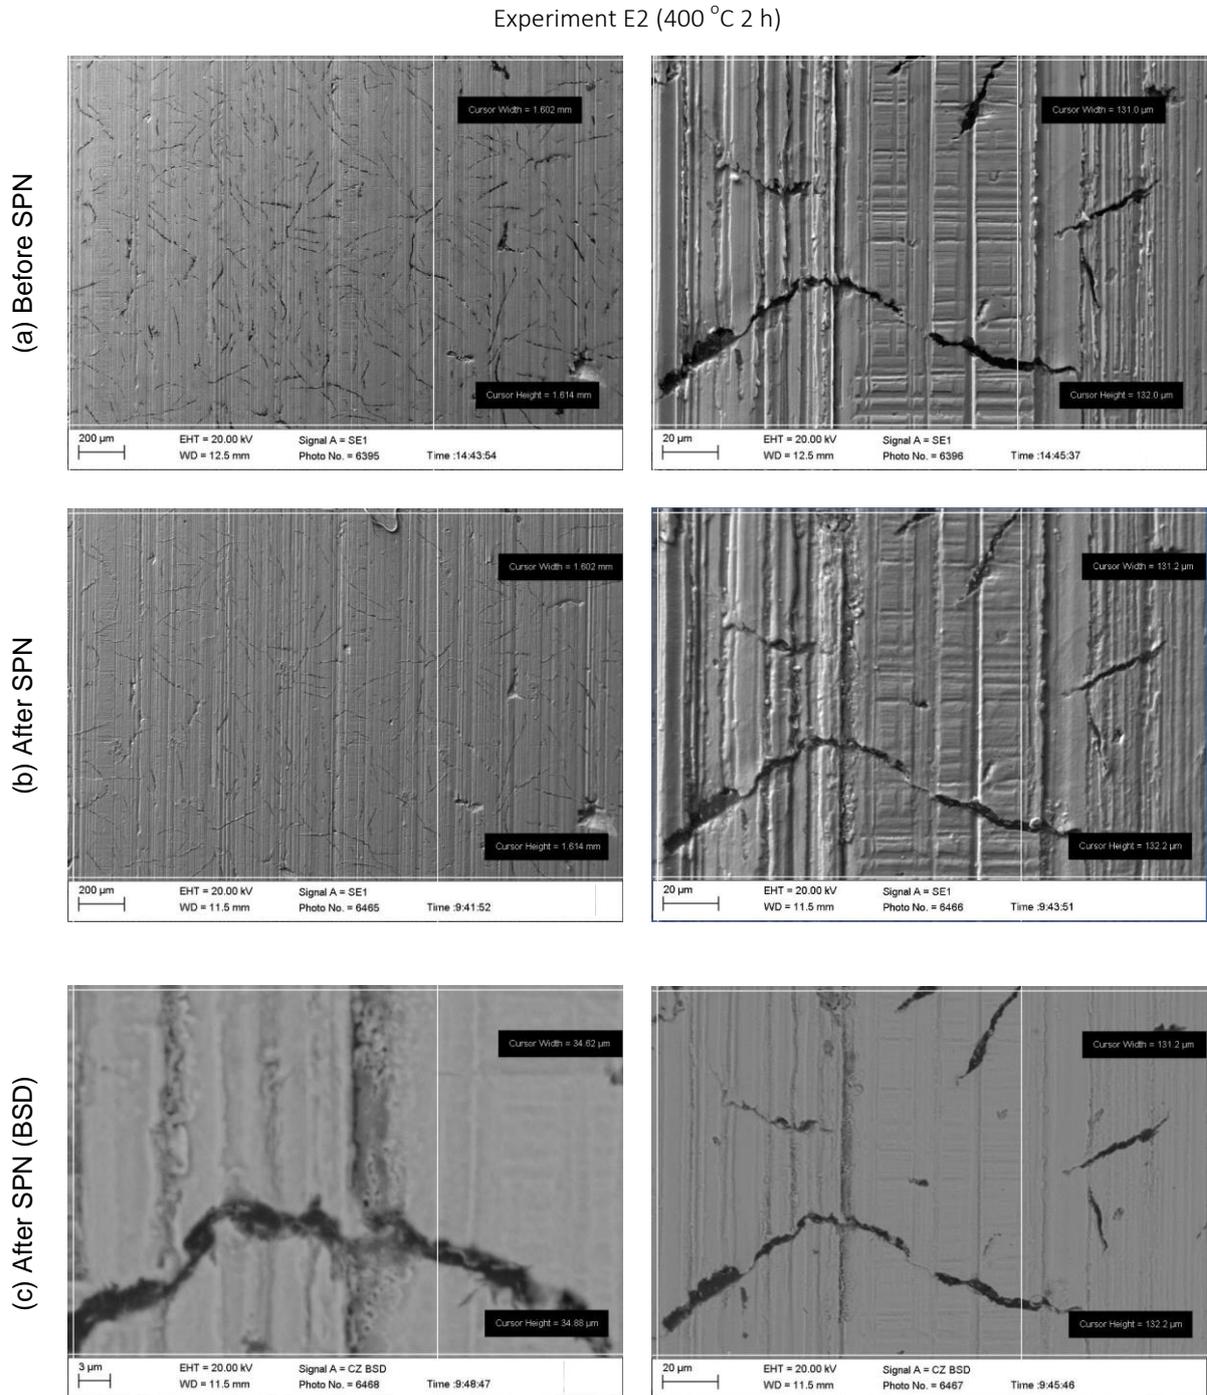
Figure 76: Experiment E2 (400 °C 2 h). Comparative Scanning Electronic Microscopy (SEM) images. Conditions (a) Before SPN, (b) After SPN - secondary electron analysis, and (c) After SPN - backscattered electron analysis.
