ON THE PLASMA-ASSISTED MODIFICATIONS OF PRE-TEXTURED SURFACES:
SHALLOW DEPTH NITRIDING IN CAST IRON, TOPOGRAPHY AND
INSTRUMENTED SCLEROMETRY TEST RESPONSE

Thesis submitted to the Polytechnic School of the University of São Paulo, in conformity with the requirements for the degree of Doctor of Science.

Metallurgical and Materials Engineering

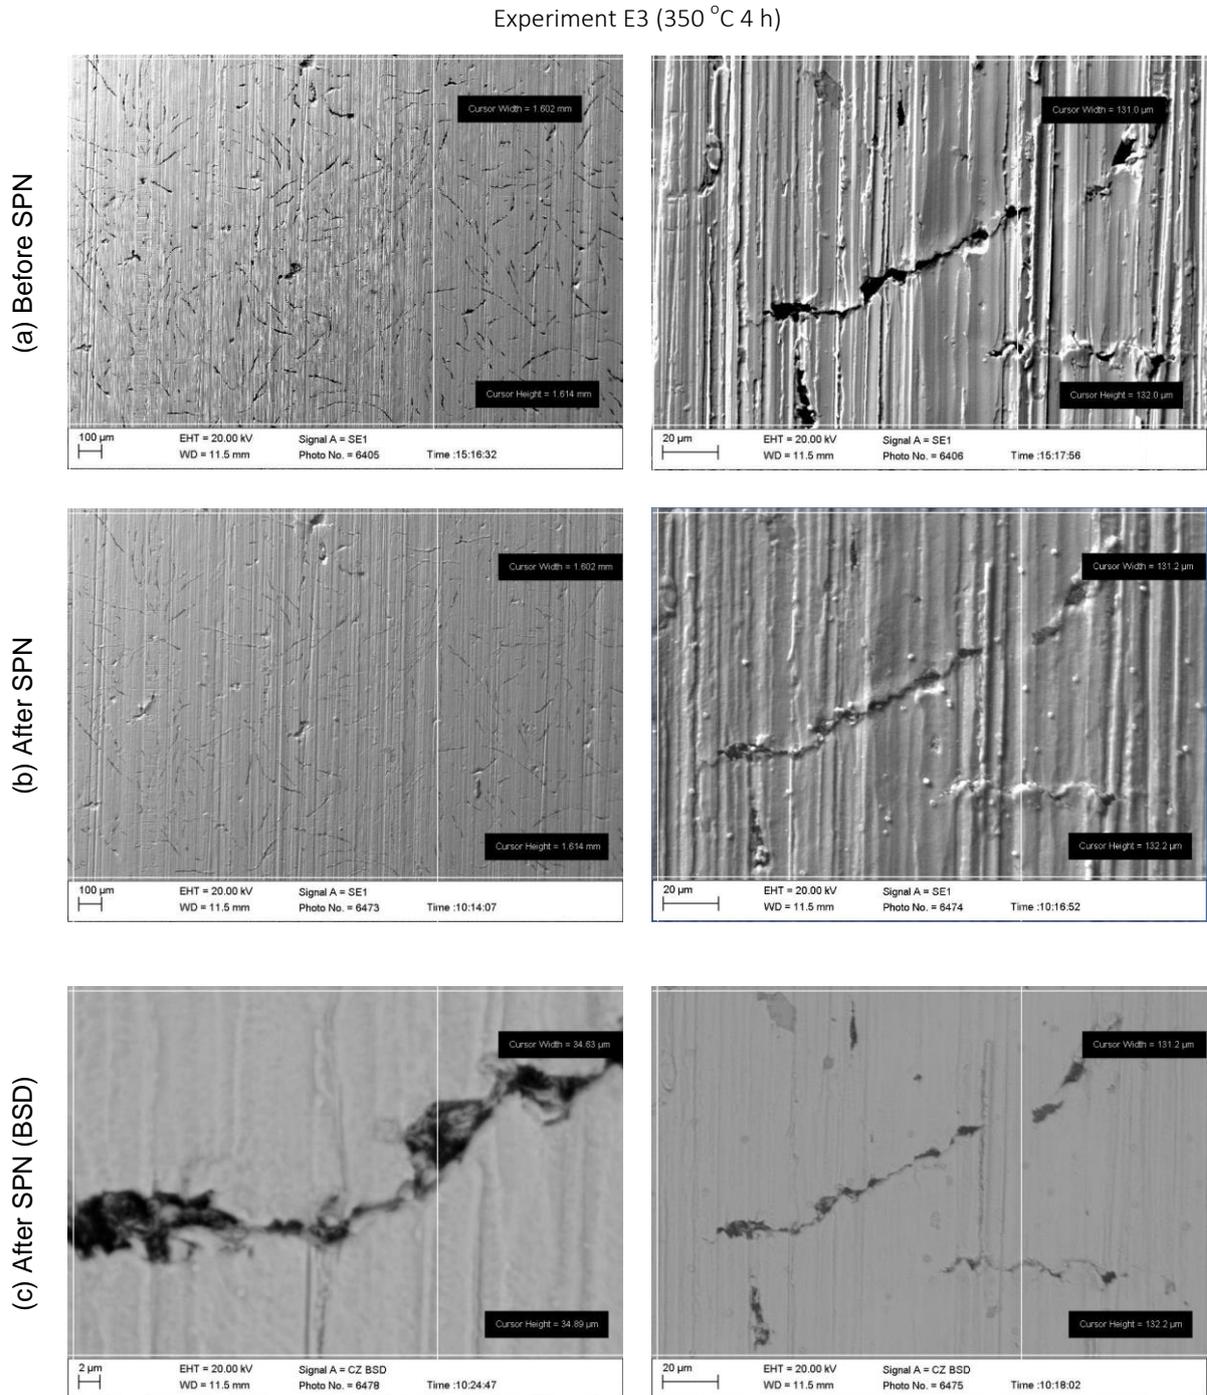
Figure 77: Experiment E3 (350 °C 4 h). Comparative Scanning Electronic Microscopy (SEM) images. Conditions (a) Before SPN, (b) After SPN - secondary electron analysis, and (c) After SPN - backscattered electron analysis.

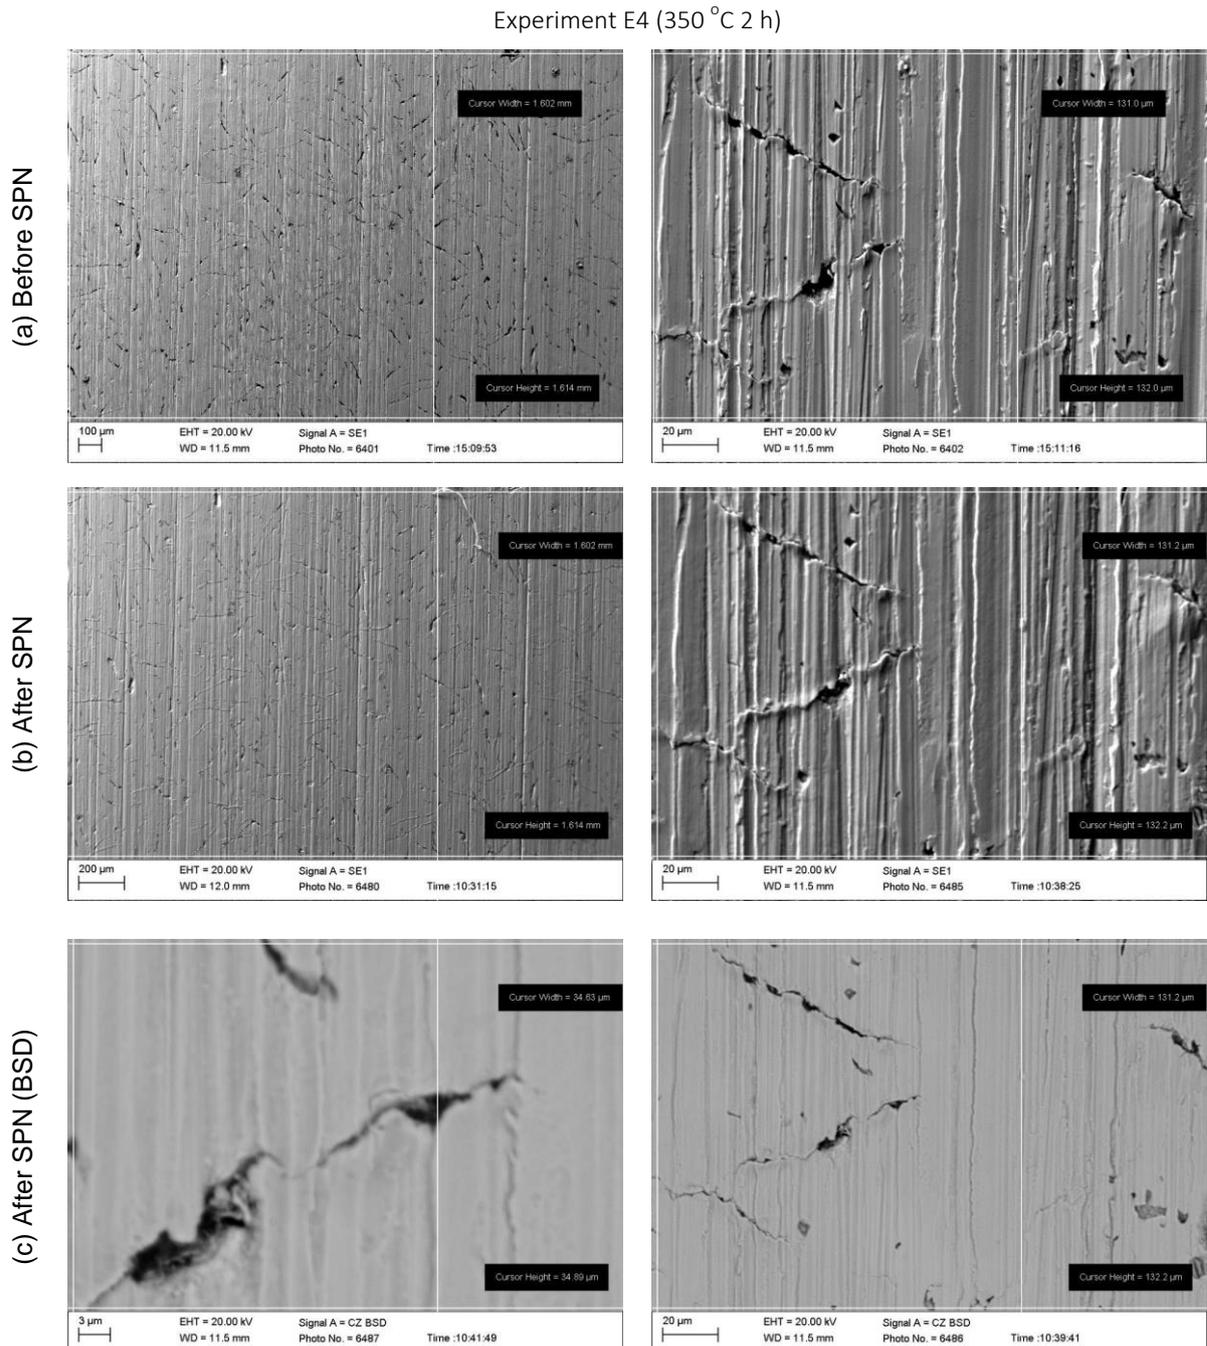
Figure 78: Experiment E4 (350 °C 2 h). Comparative Scanning Electronic Microscopy (SEM) images. Conditions (a) Before SPN, (b) After SPN - secondary electron analysis, and (c) After SPN - backscattered electron analysis.

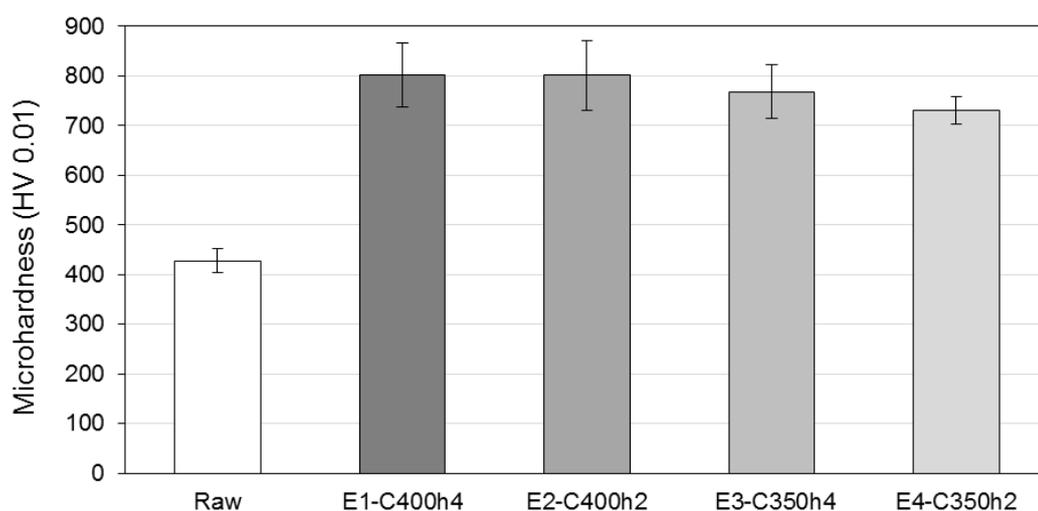
Figure 79: Microhardness (HV 0.01) on the surface (zero μm distance) measured with 10 gf. Avg values \pm std dev, $n = 5$. In-lab textured flat surface. Combined chart: Raw, E1-C400h4, E2-C400h2, E3-C350h4, E4-C350h2.

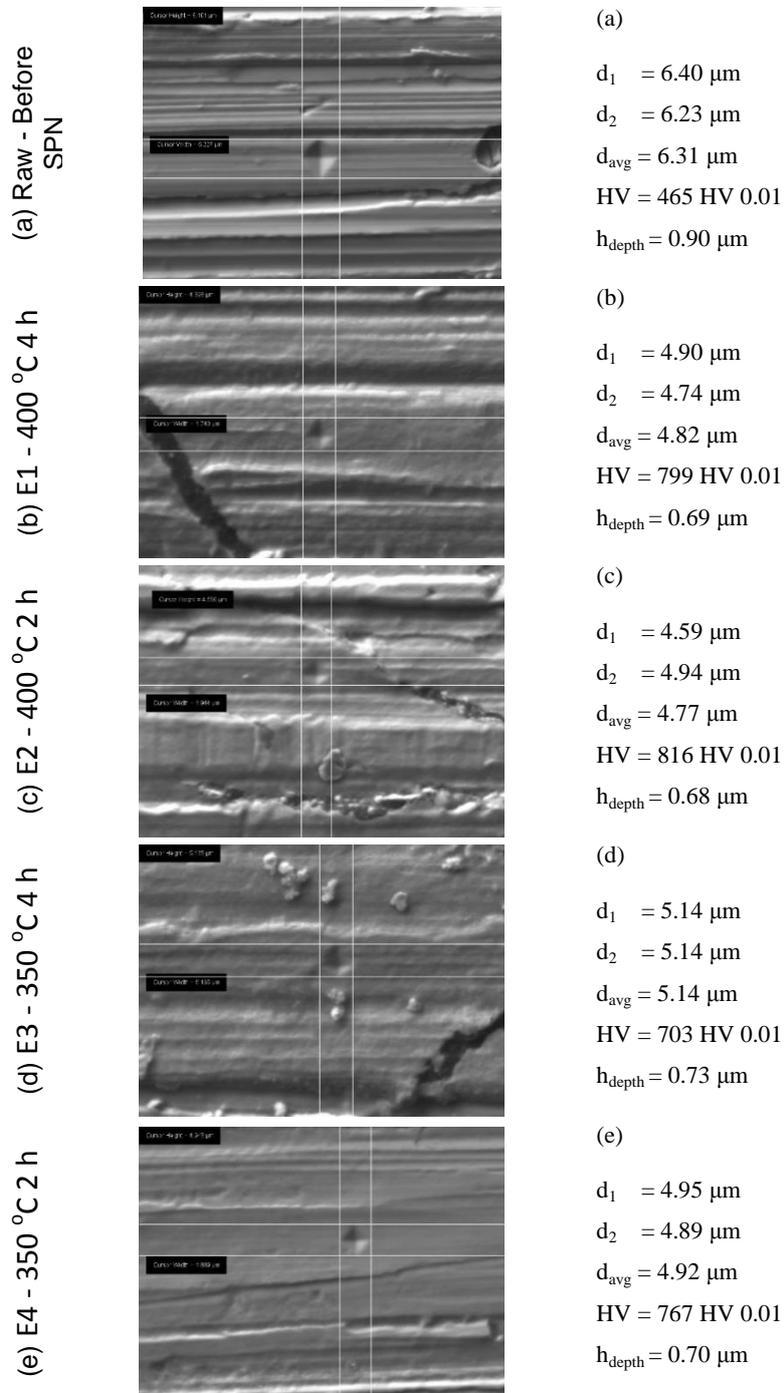
Figure 80: Examples of single indentation measured through SEM. Measurements carried out preferably on plateau regions. a) Raw, b) E1-C400h4, c) E2-C400h2, d) E3-C350h4, e) E4-C350h2. Significant hardness contrast found between raw and treated samples. SPN time has not significantly affected the range of hardness response values.

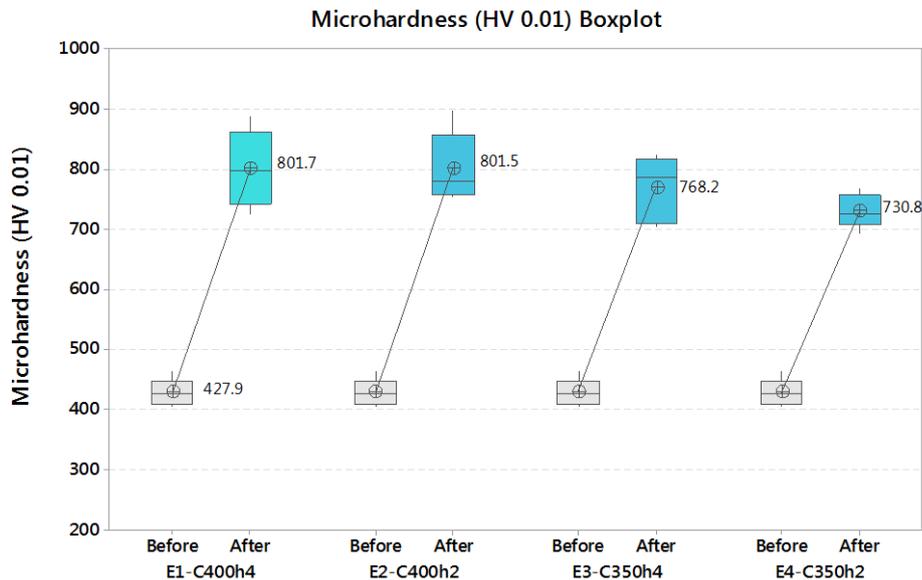
Figure 81: Boxplot of experiment results, before and after treatment. Microhardness (HV 0.01).

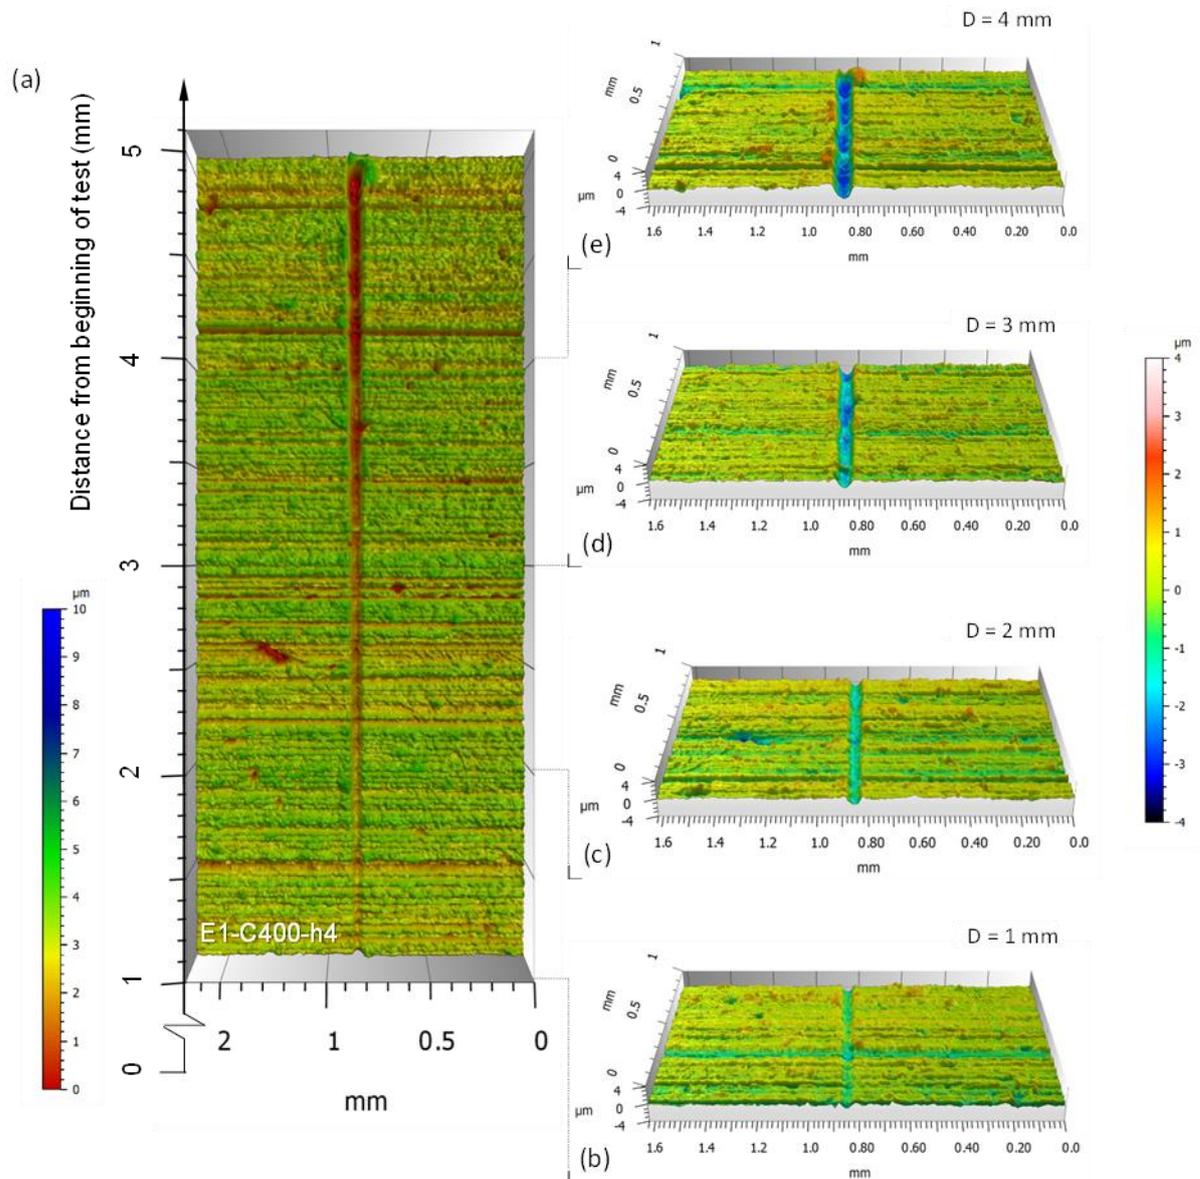
Figure 84: Instrumented linear sclerometry test. a) Top [slightly-tilted] view of the 3-D profile of the textured surface plane. Experiment E1 (400 °C 4 h). In-lab textured flat specimen. 1N pre-load applied during 10s at initial distance. Next, indenter was linearly moved increasing load, 1N to 10N, with velocity of 0.028 mm/s, resulting in the scratch of 5 mm in length. The color scale in the side indicates the resulting heights from valley to peak. b) Front [30° tilted] view of the 3-D scratch section at 1 mm distance. c-e) Similar as 'b' images at 2 mm, 3 mm and 4 mm distances, respectively, highlighting the progressive evolution of the sclerometry groove. The region 0-1 mm (test stabilization zone) was not considered in data analysis.

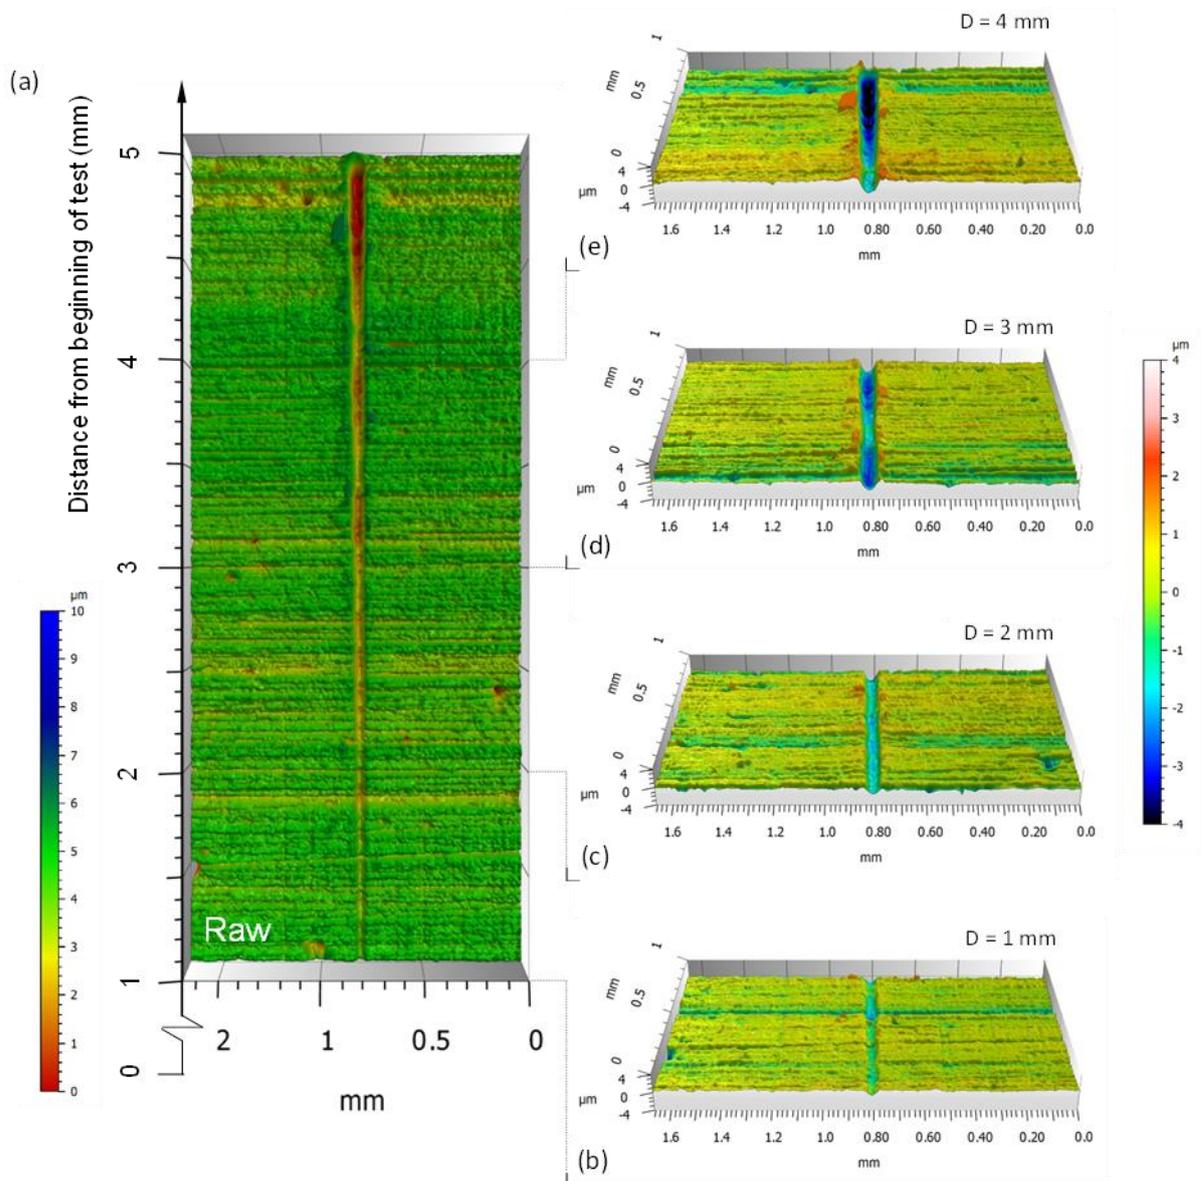
Figure 92: Instrumented linear sclerometry test. a) Top [slightly-tilted] view of the 3-D profile of the textured surface plane in the condition Raw, before SPN treatment (Baseline raw sample). In-lab textured flat specimen. 1N pre-load applied during 10s at initial distance. Next, indenter was linearly moved increasing load, 1N to 10N, with velocity of 0.028 mm/s, resulting in the scratch of 5 mm in length. The color scale in the side indicates the resulting heights from valley to peak. b) Front [30° tilted] view of the 3-D scratch section at 1 mm distance. c-e) Similar as 'b' images at 2 mm, 3 mm and 4 mm distances, respectively, highlighting the progressive evolution of the sclerometry groove. The region 0-1 mm (test stabilization zone) was not considered in data analysis.

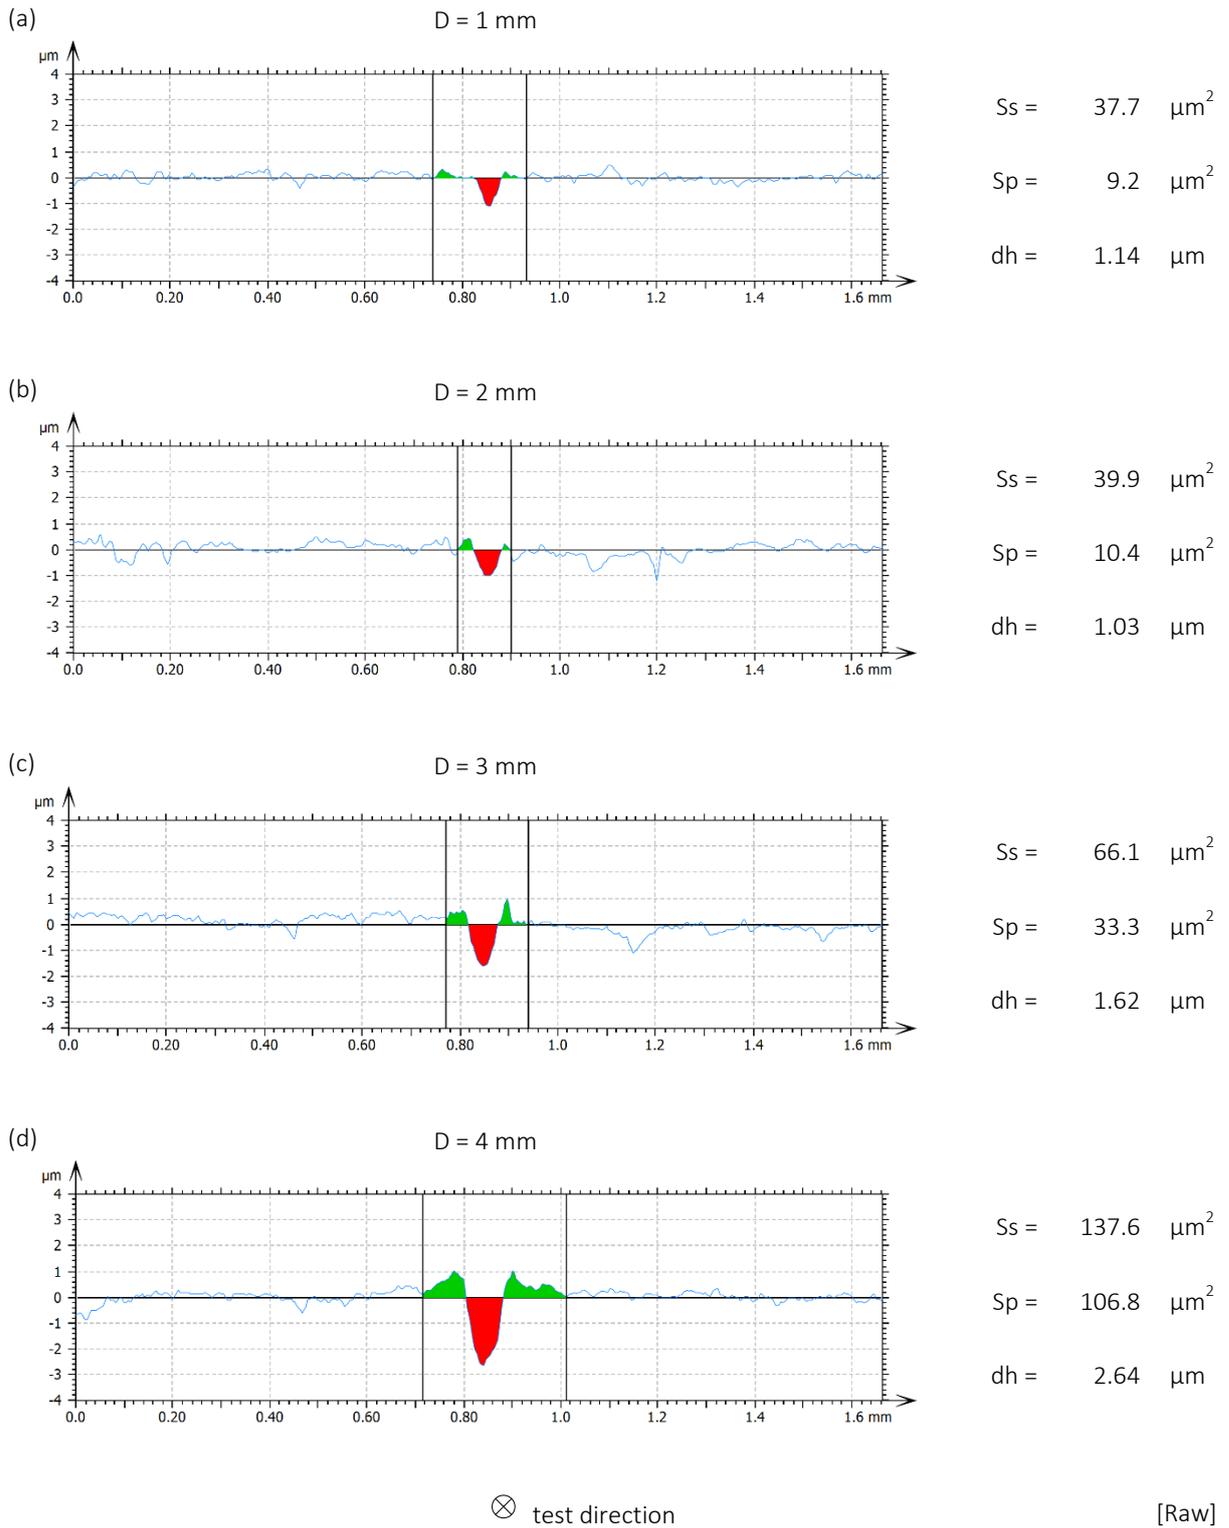
Figure 93: Instrumented linear sclerometry test. 2-D profilograms of the textured surface and resulting sclerometry groove, in the condition Raw, before SPN treatment (Baseline raw sample). In-lab textured flat specimen. Section locations corresponding to previous 3-D profile images. All the graphs: test direction towards the plane of the page. a-d) “Groove area” (Ss) - in red and “pile-up area” (Sp) - in green, at distances from beginning of test: 1 mm, 2 mm, 3 mm and 4 mm. Ss and Sp computed values reported along with each graph. In addition, punctual measurement of depth (dh) is informed.

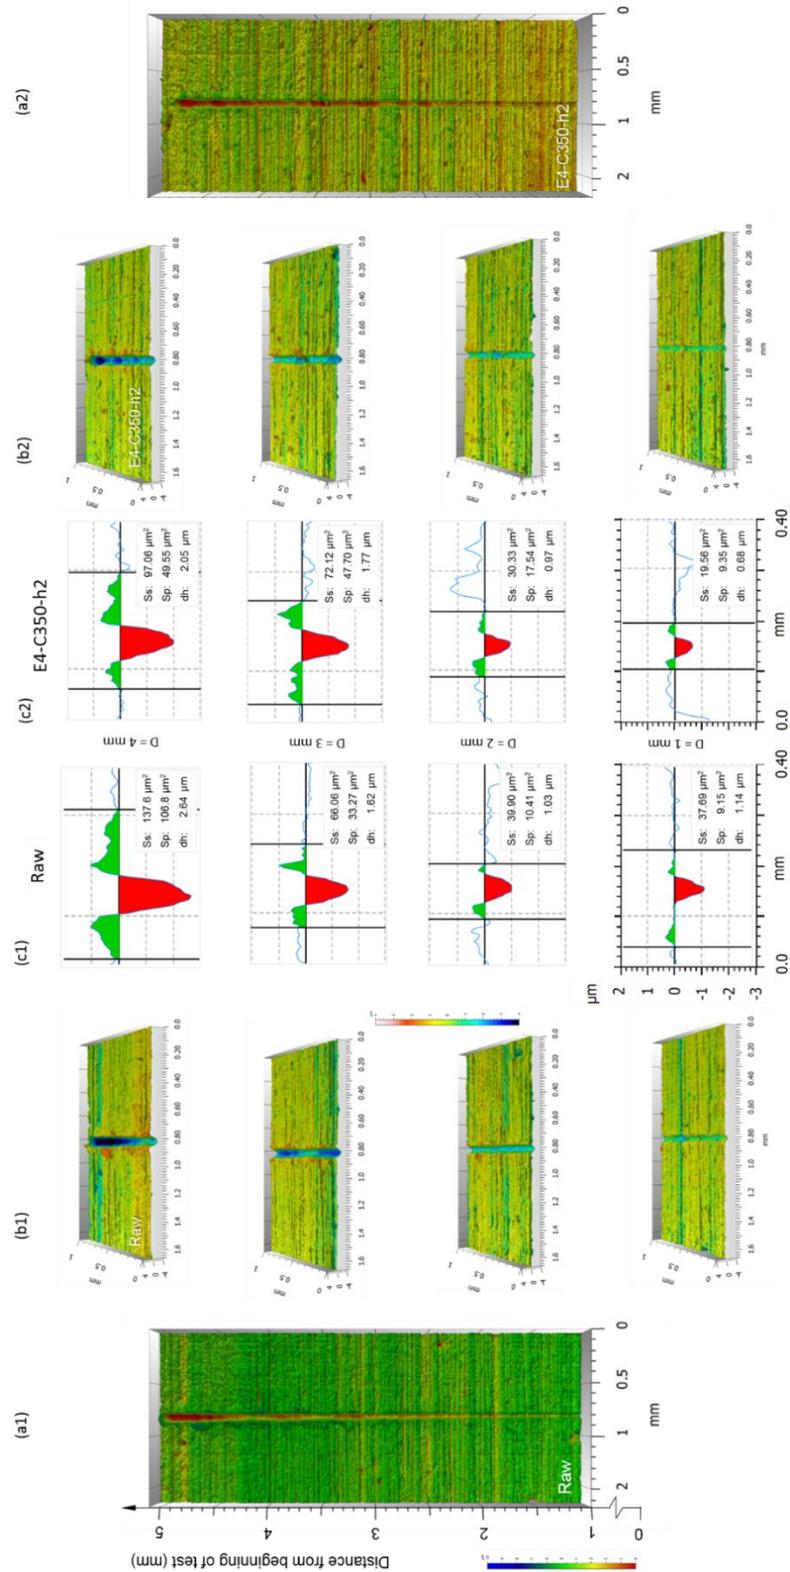
Figure 109: Instrumented linear sclerometry test. Side-by-side comparison between condition (a1-c1) Raw (before SPN) and (a2-c2) E4-C350h2. a1-2) Top [slightly-tilted] view of the 3-D profile of the textured surface plane. b1-b2) Front [30° tilted] view of the 3-D scratch section. c1-c2) Section locations corresponding to 3-D profile images. “Groove area” (Ss) - in red and “pile-up area” (Sp) - in green, at distances from beginning of test: 1 mm, 2 mm, 3 mm and 4 mm. Respective Ss, Sp, dh values are informed along with each graph. The region 0-1 mm (test stabilization zone) was not considered in data analysis. In-lab textured flat specimen.

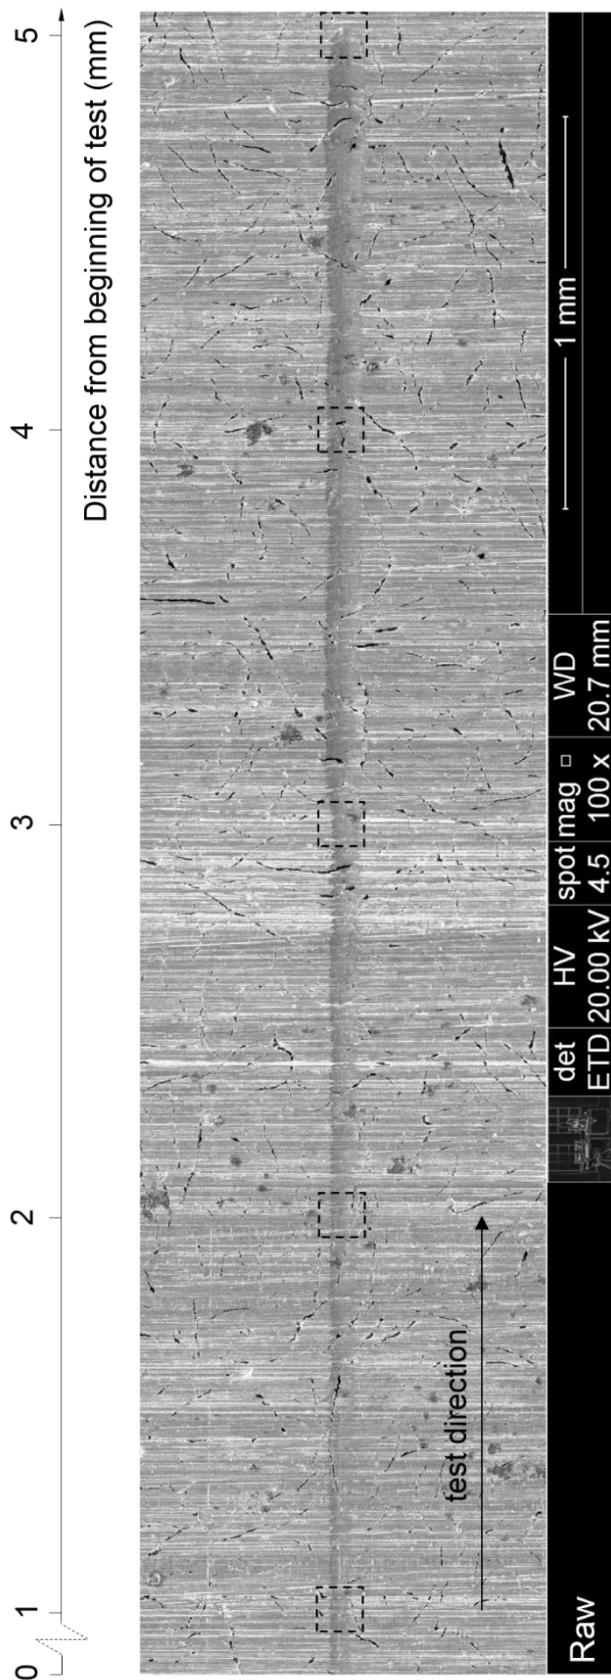
Figure 110: Instrumented linear sclerometry test. Scanning Electron Microscopy view of the textured surface plane and resulting scratch track, in the condition Raw, before SPN treatment (Baseline raw sample).

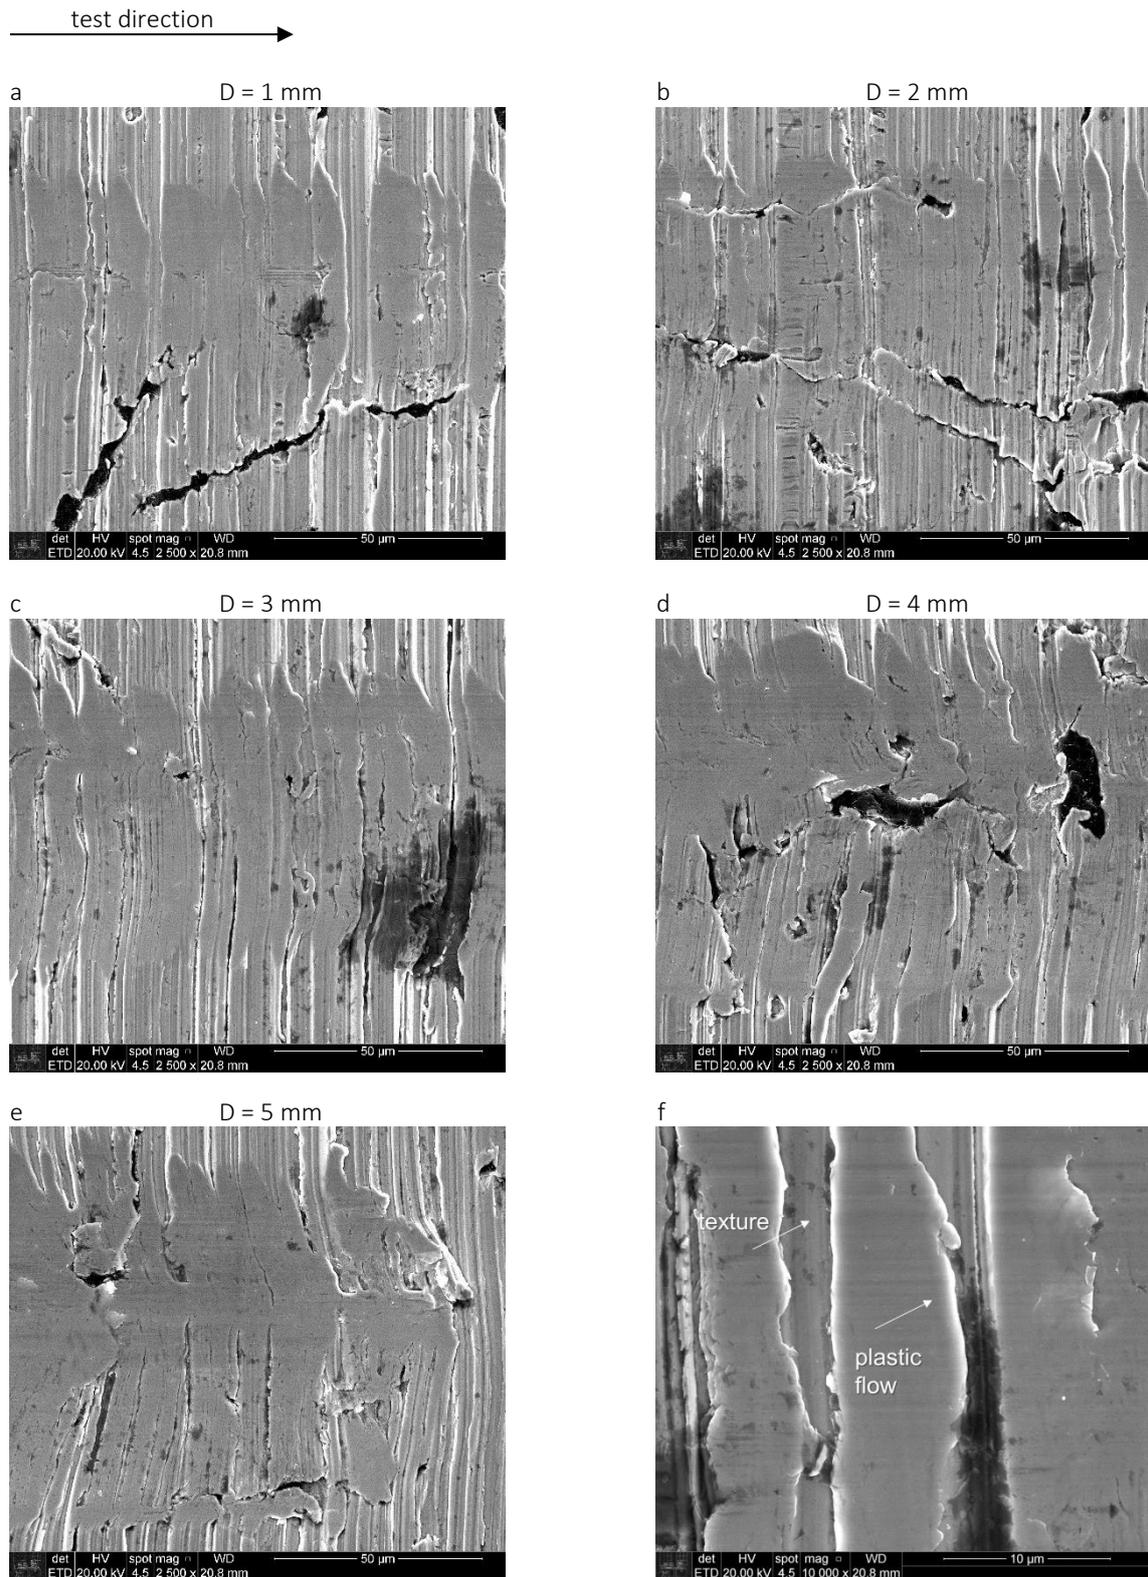
Figure 111: Instrumented linear sclerometry test. Scanning Electron Microscopy view of the textured surface plane and resulting scratch track, in the condition Raw, before SPN treatment (Baseline raw sample). All the images: test direction from left to right. a-e) Detailed view at different distances from beginning of test: 1 mm, 2 mm, 3 mm, 4 mm and 5 mm. f) Magnified view (arbitrary distance) showing plastic deformation in the interface region to the texturing grooves: a general aspect found along the scratch length of the non-treated specimen.

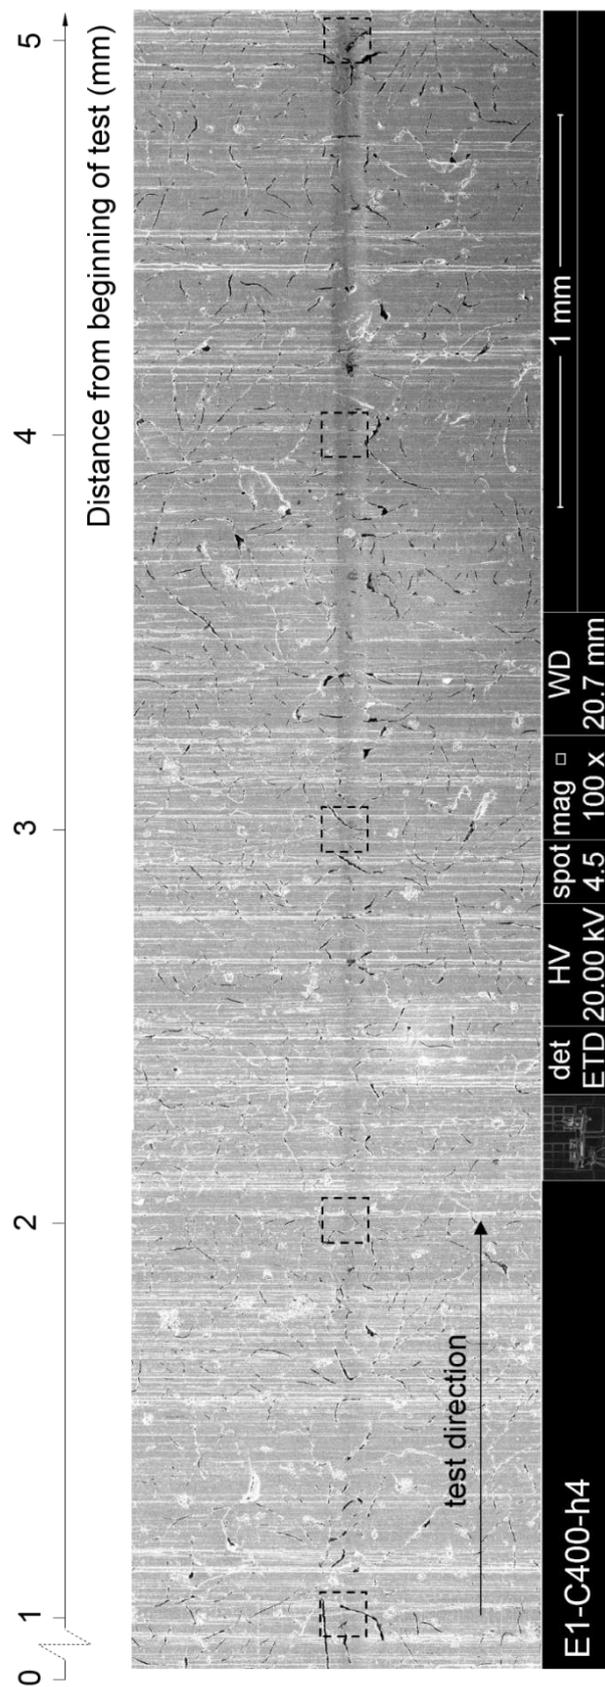
Figure 112: Instrumented linear sclerometry test. Scanning Electron Microscopy view of the textured surface plane and resulting scratch track. Experiment E1 (400 °C 4 h).

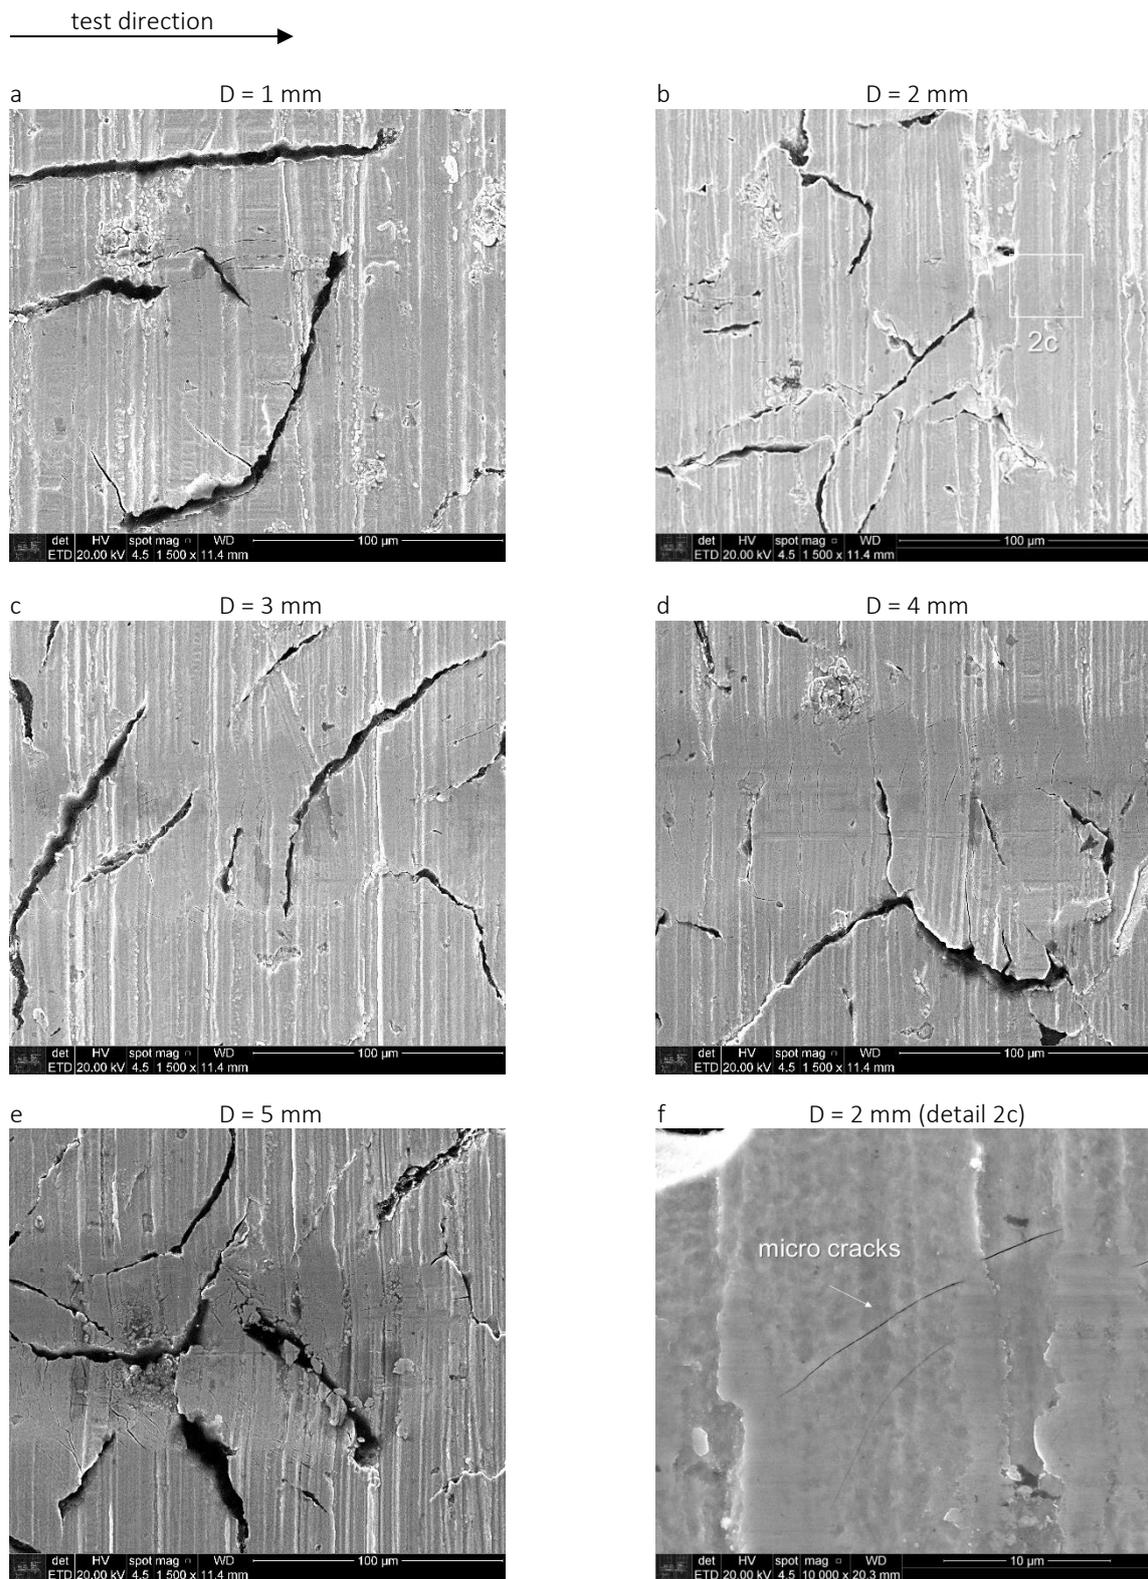
Figure 113: Instrumented linear sclerometry test. Scanning Electron Microscopy view of the textured surface plane and resulting scratch track. Experiment E1 (400 °C 4 h). All the images: test direction from left to right. a-e) Detailed view at different distances from beginning of test: 1 mm, 2 mm, 3 mm, 4 mm and 5 mm. Microcracks found preferably in graphite regions. f) Magnified view (detail 2C of Fig. b) showing tensile microcracks at distance around 2 mm, in material matrix region, i.e., out of graphite pocket surroundings.

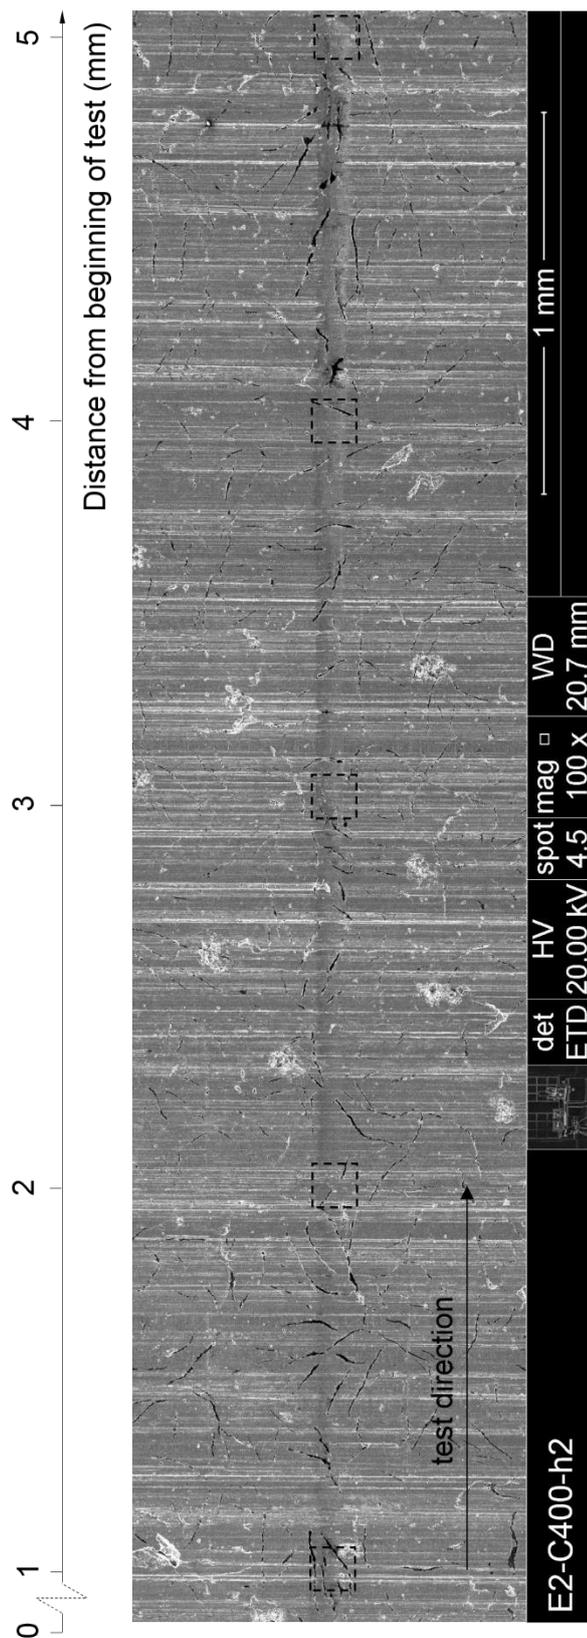
Figure 114: Instrumented linear sclerometry test. Scanning Electron Microscopy view of the textured surface plane and resulting scratch track. Experiment E2 (400 °C 2 h).

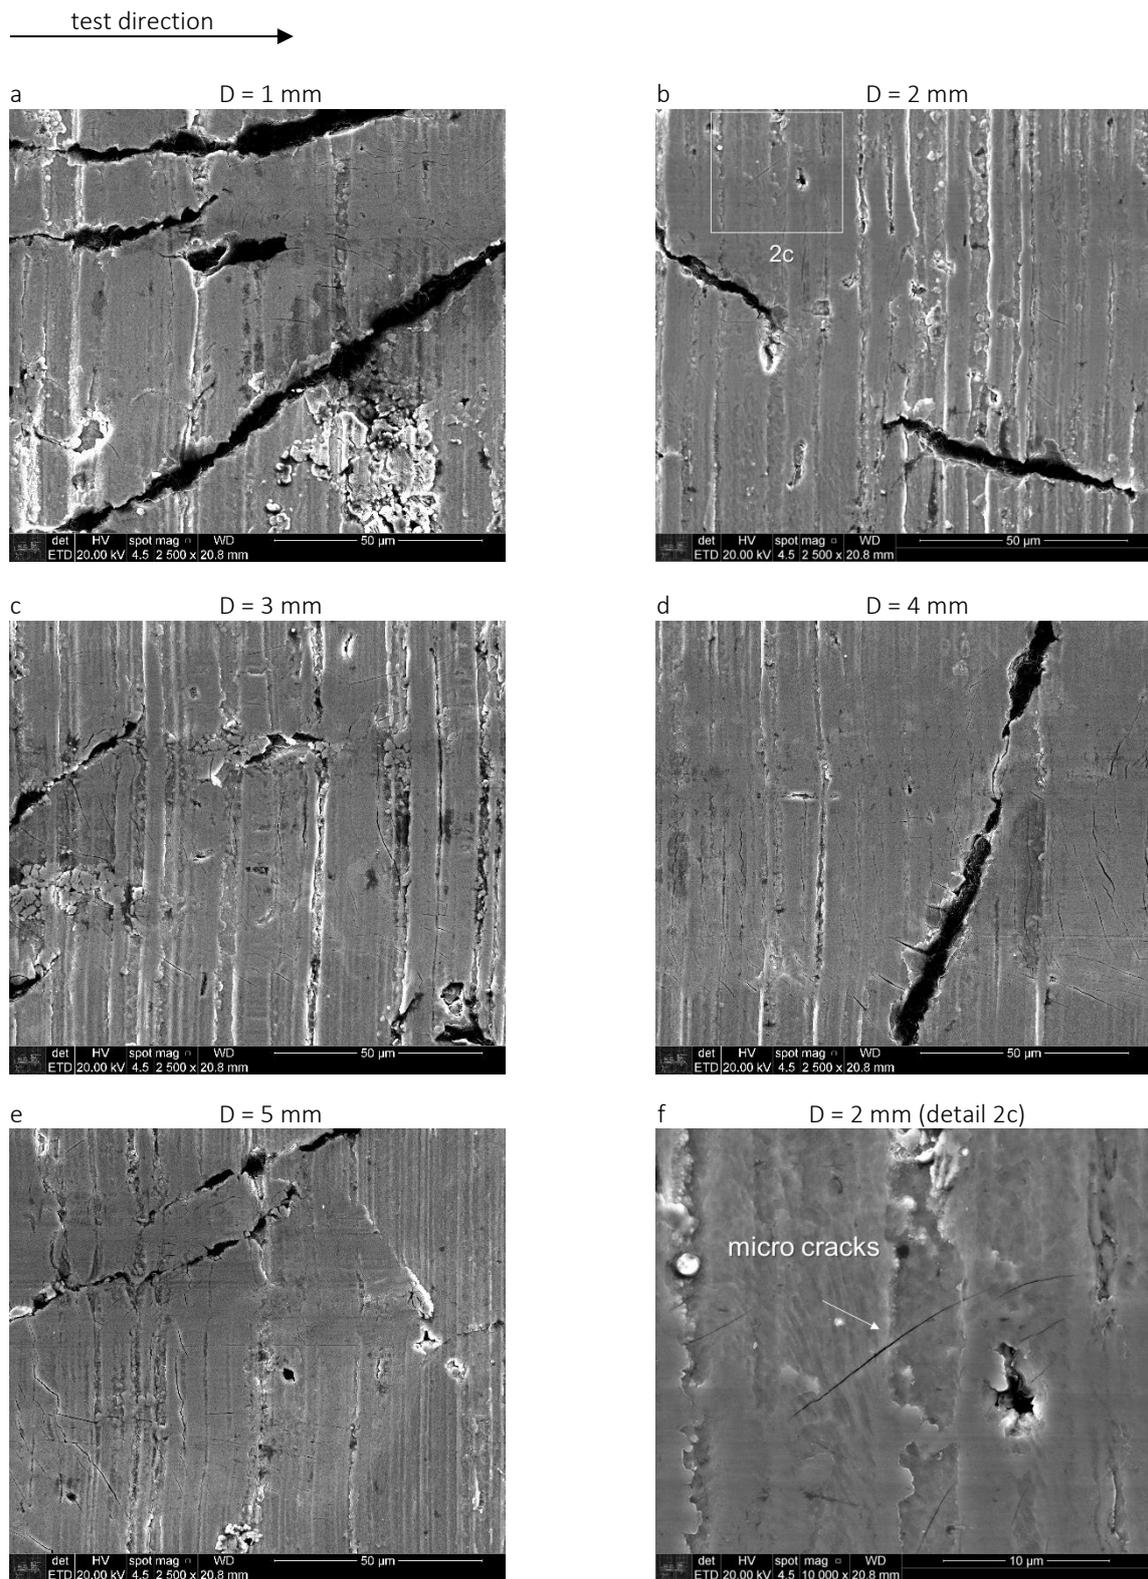
Figure 115: Instrumented linear sclerometry test. Scanning Electron Microscopy view of the textured surface plane and resulting scratch track. Experiment E2 (400 °C 2 h). All the images: test direction from left to right. a-e) Detailed view at different distances from beginning of test: 1 mm, 2 mm, 3 mm, 4 mm and 5 mm. Microcracks found preferably in graphite regions. f) Magnified view (detail 2C of Fig. b) showing tensile microcracks at distance around 2 mm, in material matrix region, i.e., out of graphite pocket surroundings.

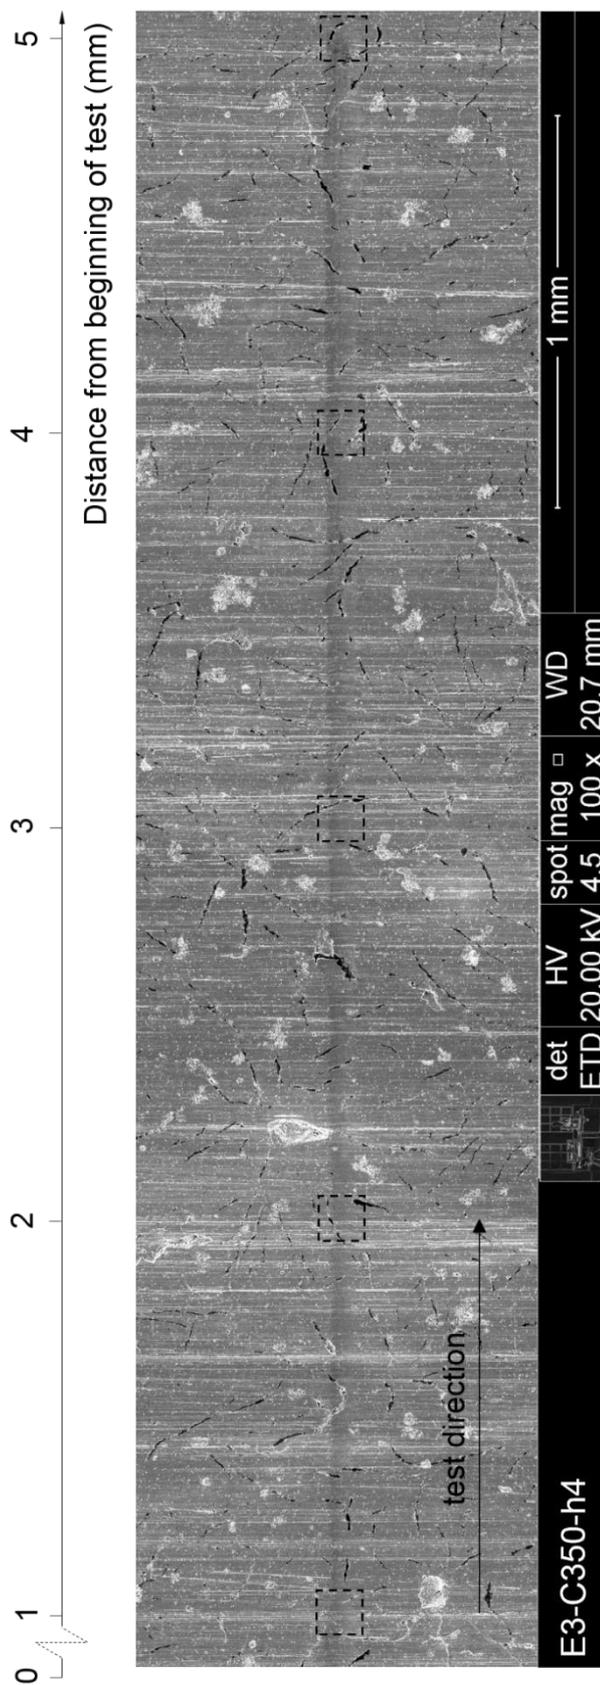
Figure 116: Instrumented linear sclerometry test. Scanning Electron Microscopy view of the textured surface plane and resulting scratch track. Experiment E3 (350 °C 4 h).
