ON THE PLASMA-ASSISTED MODIFICATIONS OF PRE-TEXTURED SURFACES:
SHALLOW DEPTH NITRIDING IN CAST IRON, TOPOGRAPHY AND
INSTRUMENTED SCLEROMETRY TEST RESPONSE

Thesis submitted to the Polytechnic School of the University of São Paulo, in conformity with the requirements for the degree of Doctor of Science.

Metallurgical and Materials Engineering

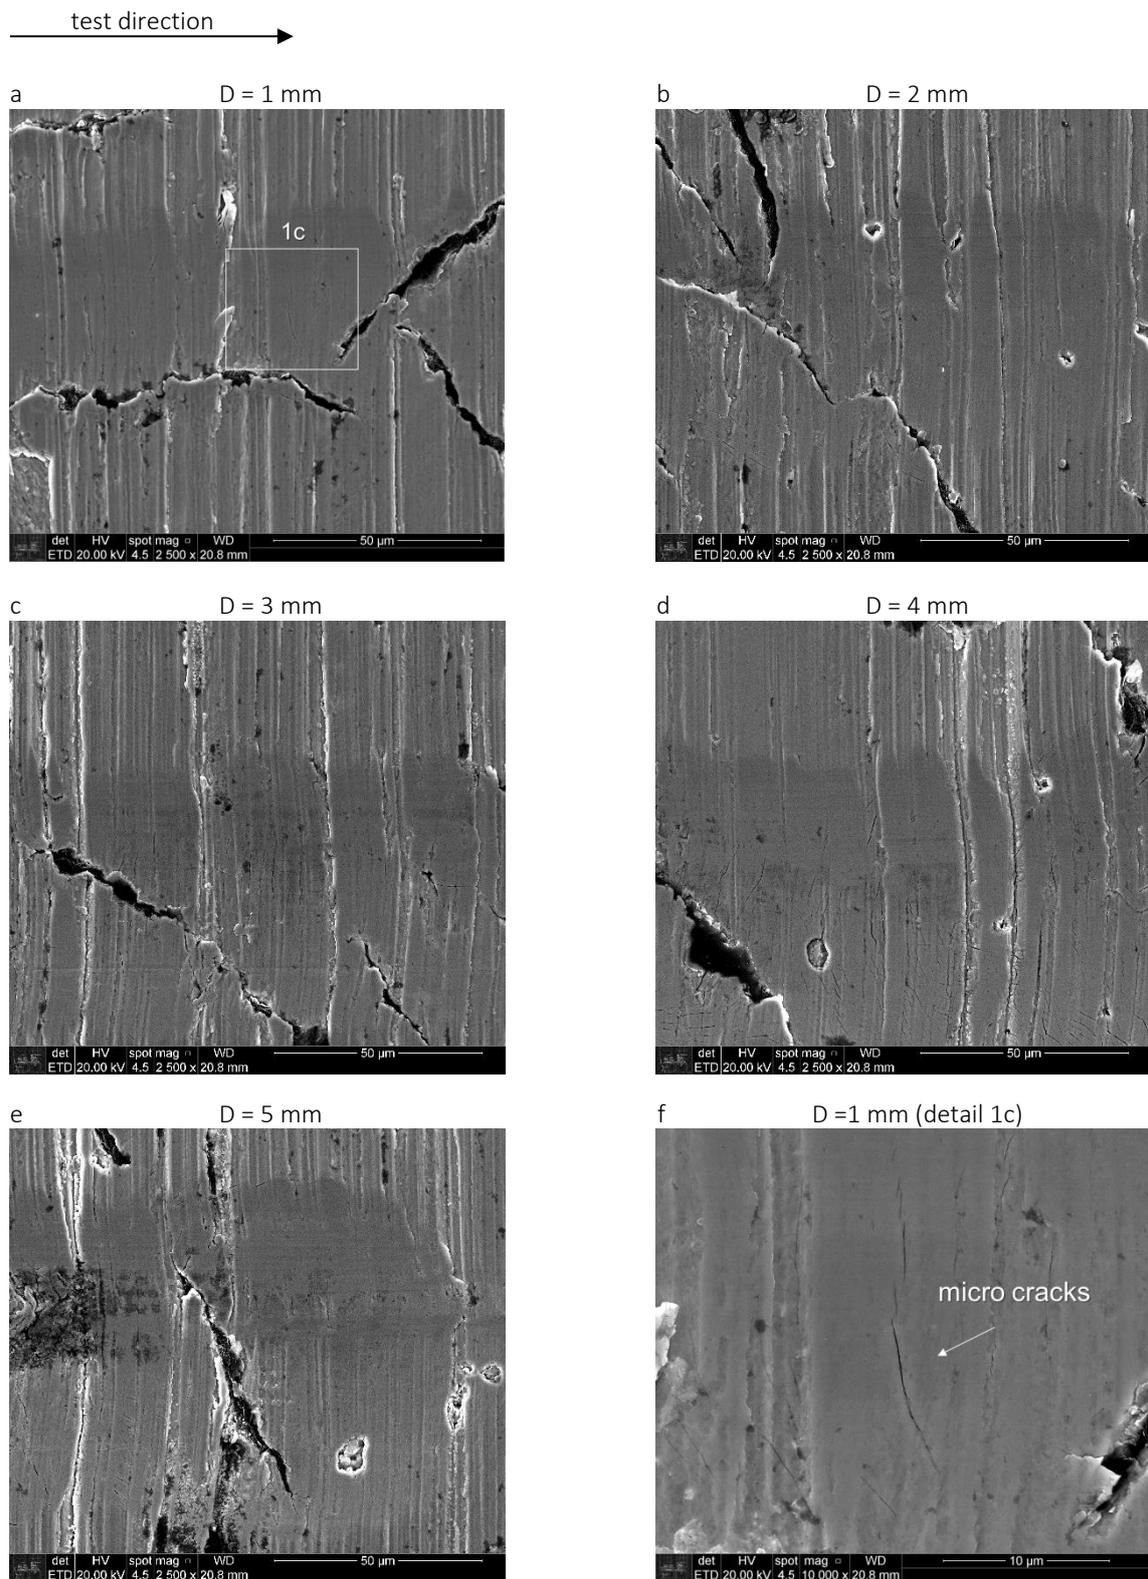
Figure 119: Instrumented linear sclerometry test. Scanning Electron Microscopy view of the textured surface plane and resulting scratch track. Experiment E4 (350 °C 2 h). All the images: test direction from left to right. a-e) Detailed view at different distances from beginning of test: 1 mm, 2 mm, 3 mm, 4 mm and 5 mm. f) Magnified view (detail 1C of Fig. a) showing tensile microcracks at distance around 1 mm, in material matrix region, i.e., out of graphite pocket surroundings.

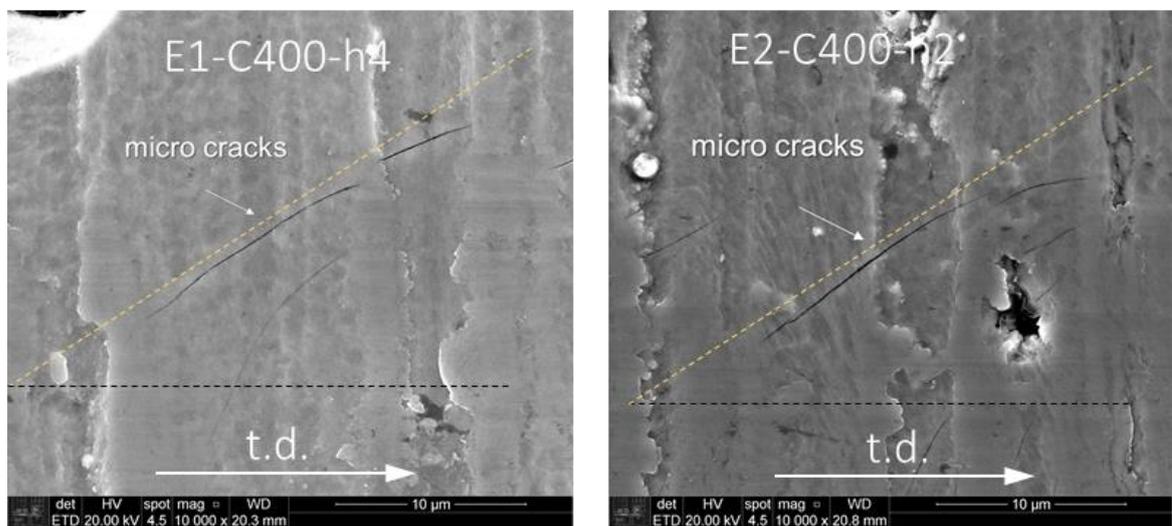
Figure 120: Condition E1-C400h4 and E2-C400h2. SEM view of the textured surface at the distance $D = 2$ mm from beginning of test. Microcracks nucleated in the matrix, at similar orientation angle. Region free from graphite flakes. Same regions as shown in the previous sequences of images of Figure 113 and Figure 115.

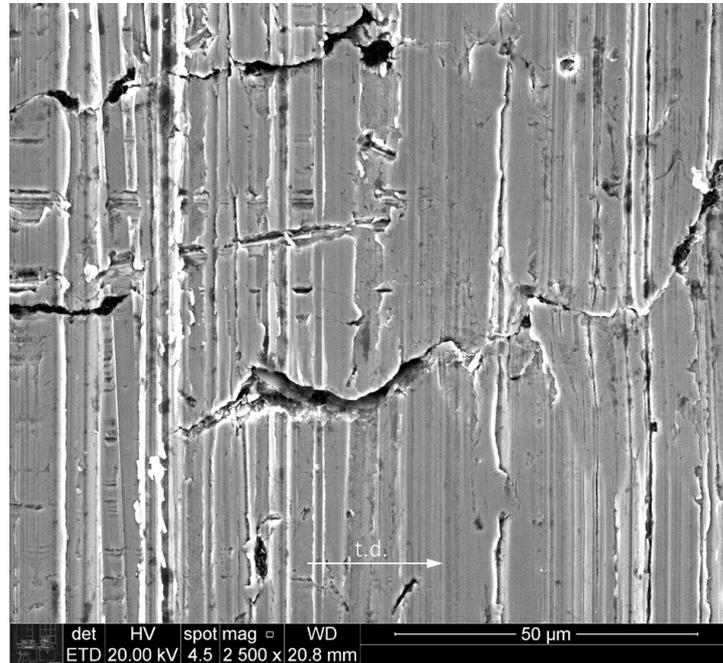
Figure 121: Condition Raw, before SPN treatment. SEM view of the textured surface at the starting distance from beginning of test, $D = 0$ mm. At this point, 1N pre-load was applied. Compared to larger distances (Figure 111), minor plastic deformation was noticed. Texturing grooves and graphite pocket are suitably preserved.

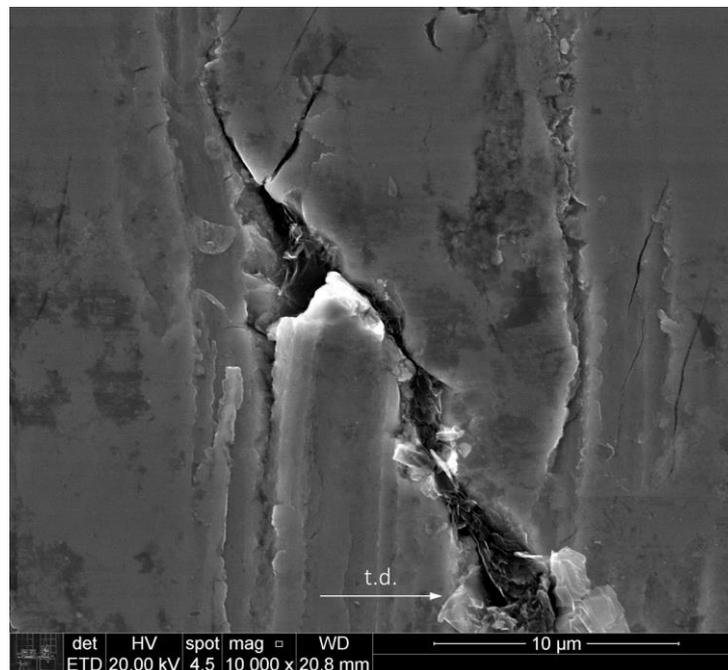
Figure 123: Condition E4-C350h2. SEM view of the textured surface at the ending distance $D = 5$ mm of test. Microcracks nucleated in association to a graphite pocket interface (graphite tip), which acts as a stress concentrator. On the right, microcracks nucleated in the material matrix region.

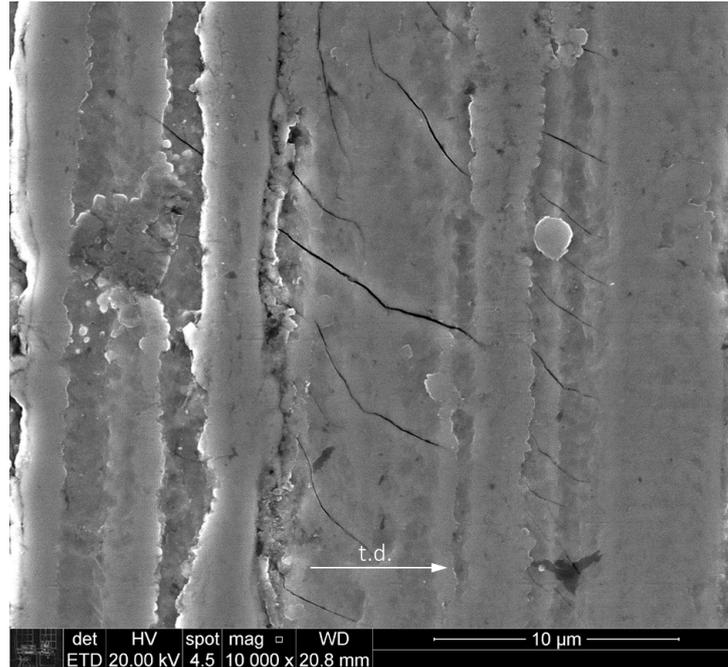
Figure 124: Condition E2-C400h2. SEM view of the textured surface at the distance $D = 2$ mm from beginning of test. Sequence of parallel microcracks nucleated in the matrix. Region free from graphite flakes.

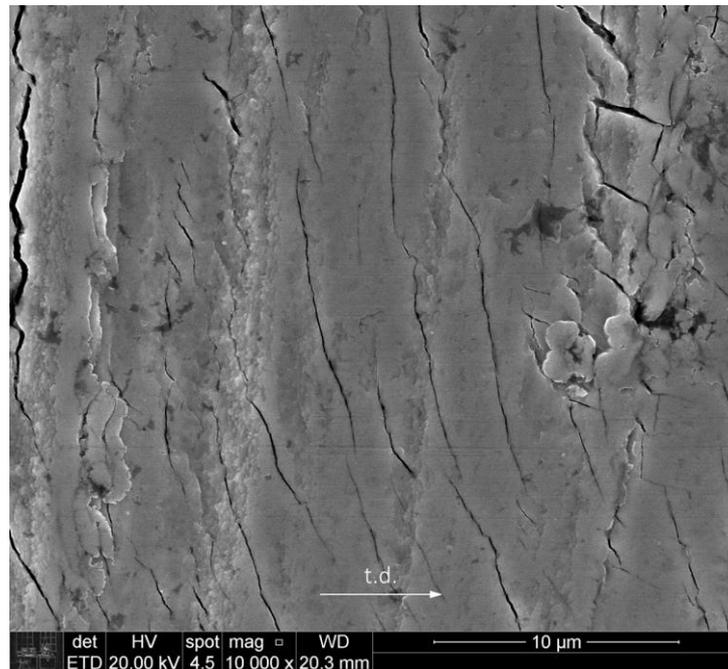
Figure 125: Condition E3-C350h4. SEM view of the textured surface at the ending distance $D = 5$ mm of test, where the normal load achieved its maximum intensity. The image field is filled out by a cluster of microcracks. Region free from graphite flakes.

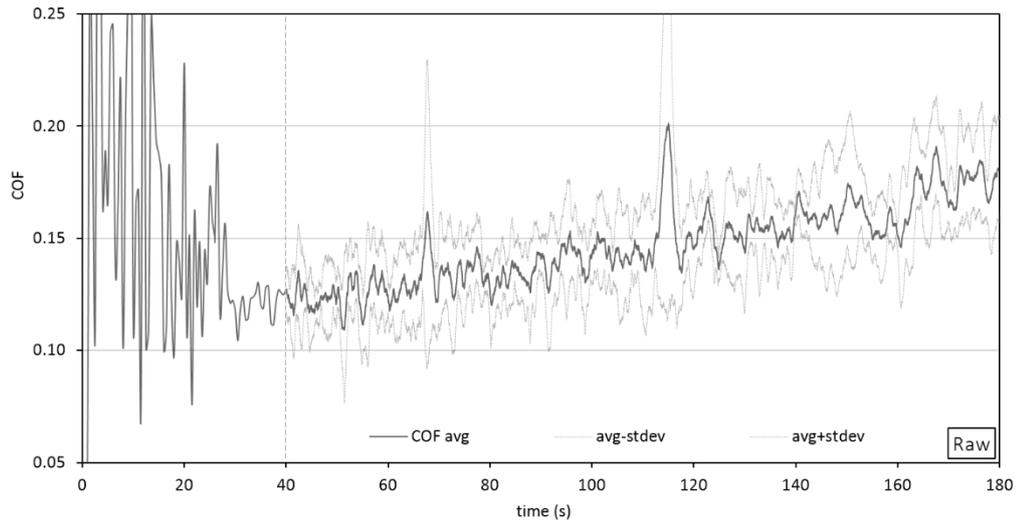
Figure 126: Apparent COF of the textured surface in condition Raw, before SPN treatment (Baseline sample). Avg values \pm std dev, $n = 5$. In-lab textured flat specimen. 1N pre-load applied during 10s. Next, indenter was linearly moved increasing load, 1N to 10N, with velocity of 0.028 mm/s, during 180 s, resulting in the scratch of 5 mm in length. The test stabilization was comprehended into first 40 s (dashed line) and is not considered in data analysis.

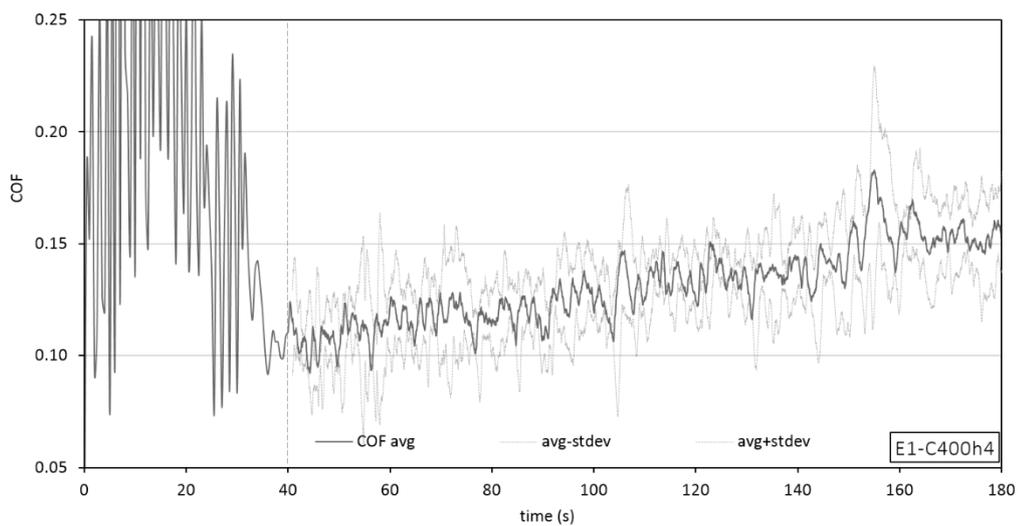
Figure 127: Apparent COF of the textured surface treated in condition E1-C400h4. Avg values \pm std dev, $n = 5$. In-lab textured flat specimen. 1N pre-load applied during 10s. Next, indenter was linearly moved increasing load, 1N to 10N, with velocity of 0.028 mm/s, during 180 s, resulting in the scratch of 5 mm in length. The test stabilization was comprehended into first 40 s (dashed line) and is not considered in data analysis.

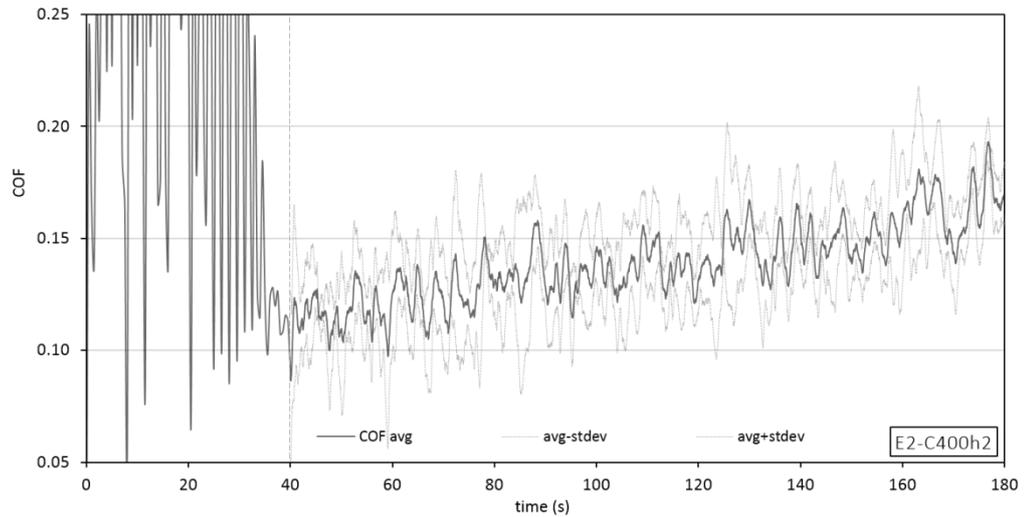
Figure 128: Apparent COF of the textured surface treated in condition E2-C400h2. Avg values \pm std dev, $n = 5$. In-lab textured flat specimen. 1N pre-load applied during 10s. Next, indenter was linearly moved increasing load, 1N to 10N, with velocity of 0.028 mm/s, during 180 s, resulting in the scratch of 5 mm in length. The test stabilization was comprehended into first 40 s (dashed line) and is not considered in data analysis.

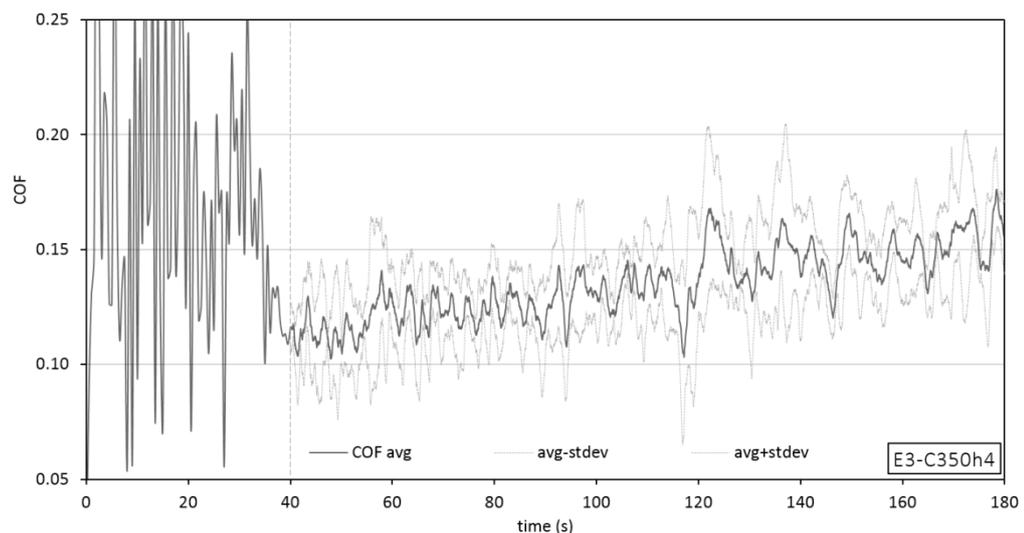
Figure 129: Apparent COF of the textured surface treated in condition E3-C350h4. Avg values \pm std dev, $n = 5$. In-lab textured flat specimen. 1N pre-load applied during 10s. Next, indenter was linearly moved increasing load, 1N to 10N, with velocity of 0.028 mm/s, during 180 s, resulting in the scratch of 5 mm in length. The test stabilization was comprehended into first 40 s (dashed line) and is not considered in data analysis.

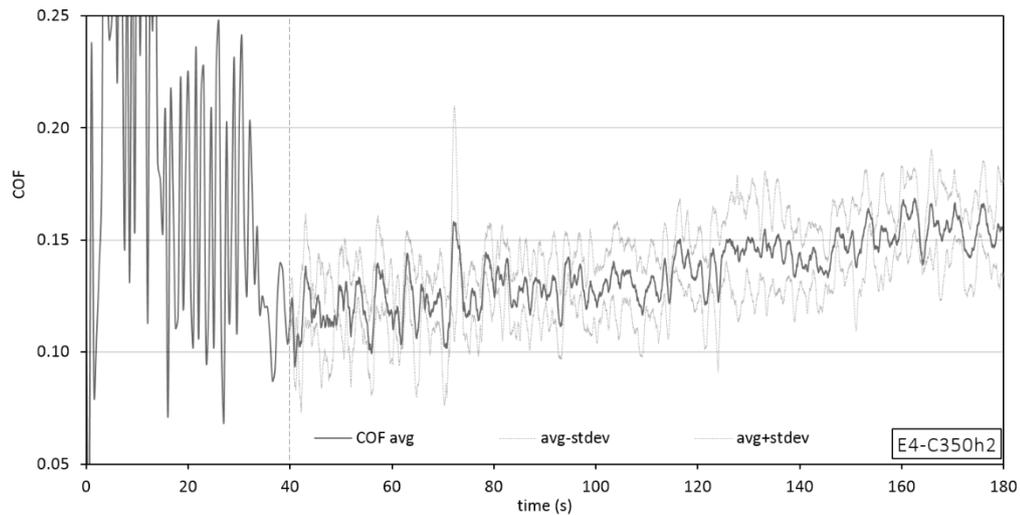
Figure 130: Apparent COF of the textured surface treated in the condition E4-C350h2. Avg values \pm std dev, $n = 5$. In-lab textured flat specimen. 1N pre-load applied during 10s. Next, indenter was linearly moved increasing load, 1N to 10N, with velocity of 0.028 mm/s, during 180 s, resulting in the scratch of 5 mm in length. The test stabilization was comprehended into first 40 s (dashed line) and is not considered in data analysis.

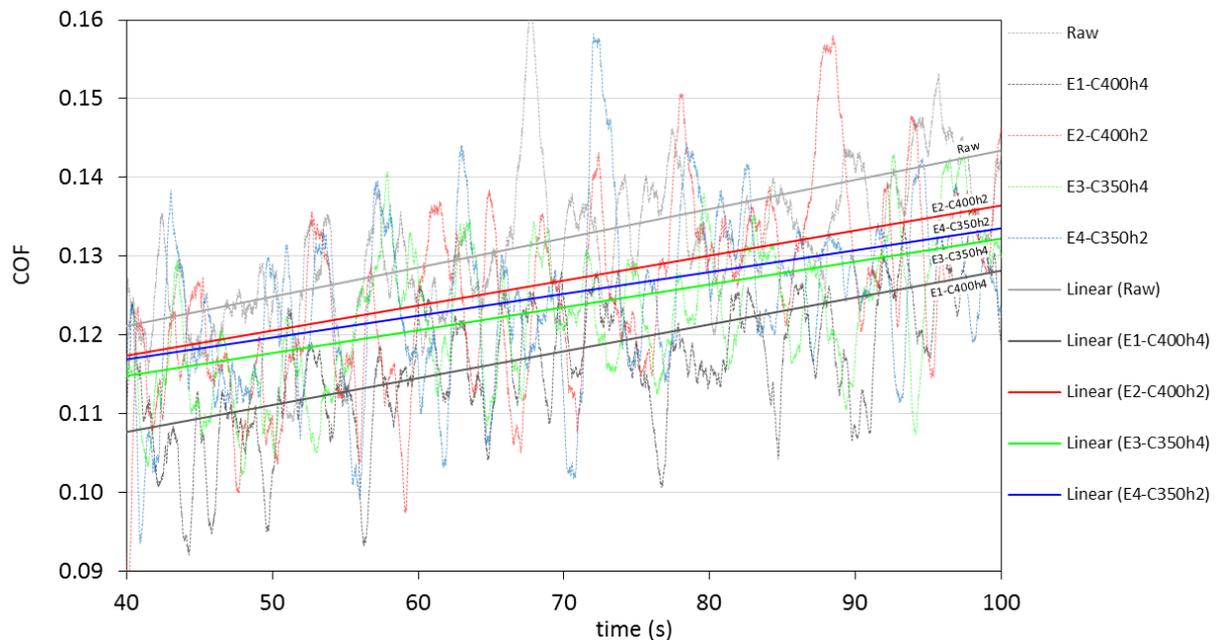
Figure 131: Apparent COF of the textured surface. Combined chart: Raw, E1-400C-4h, E2-400C-2h, E3-350C-4h, E4-350-2h. Avg values and respective linear regression line, $n = 5$. In-lab textured flat specimen.

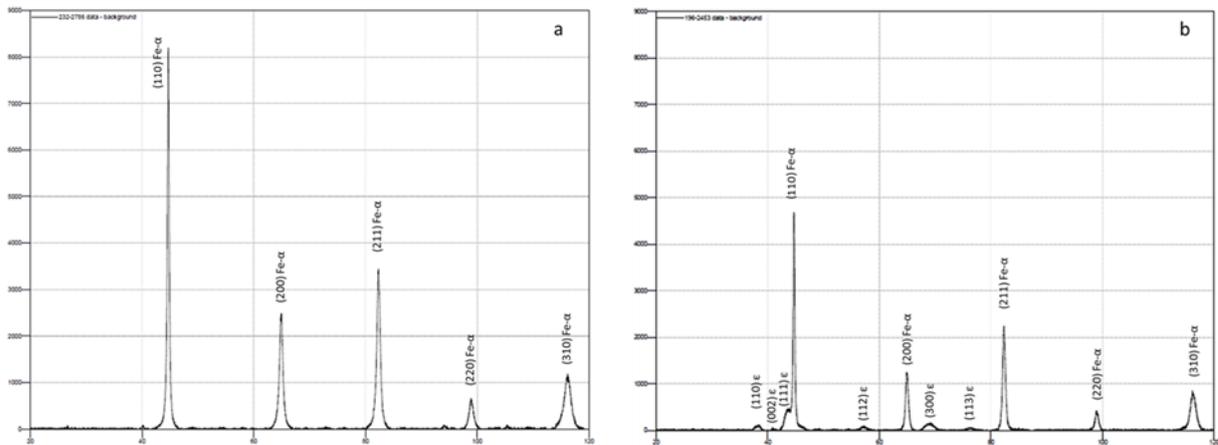
Figure 141: XRD diffractograms of the textured surface in the condition a) before SPN treatment (CS-Raw) and b) after SPN treatment (CS-C350h2). Background filter was applied. Crystallographica Search-Match (CSM) software.

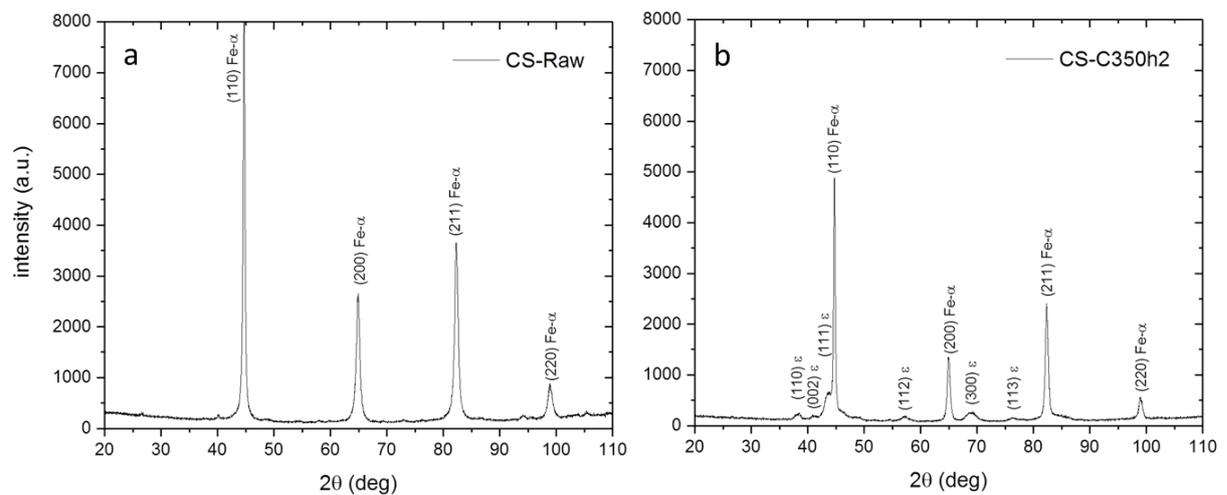
Figure 142: XRD diffractograms of the textured surface in the condition a) before SPN treatment (CS-Raw) and b) after SPN treatment (CS-C350h2). ϵ -nitride (Fe₃N) peaks growth and reduction in Fe- α peaks intensity were evidenced through direct comparison between charts. Background filter was not applied. Origin 9.4 software.

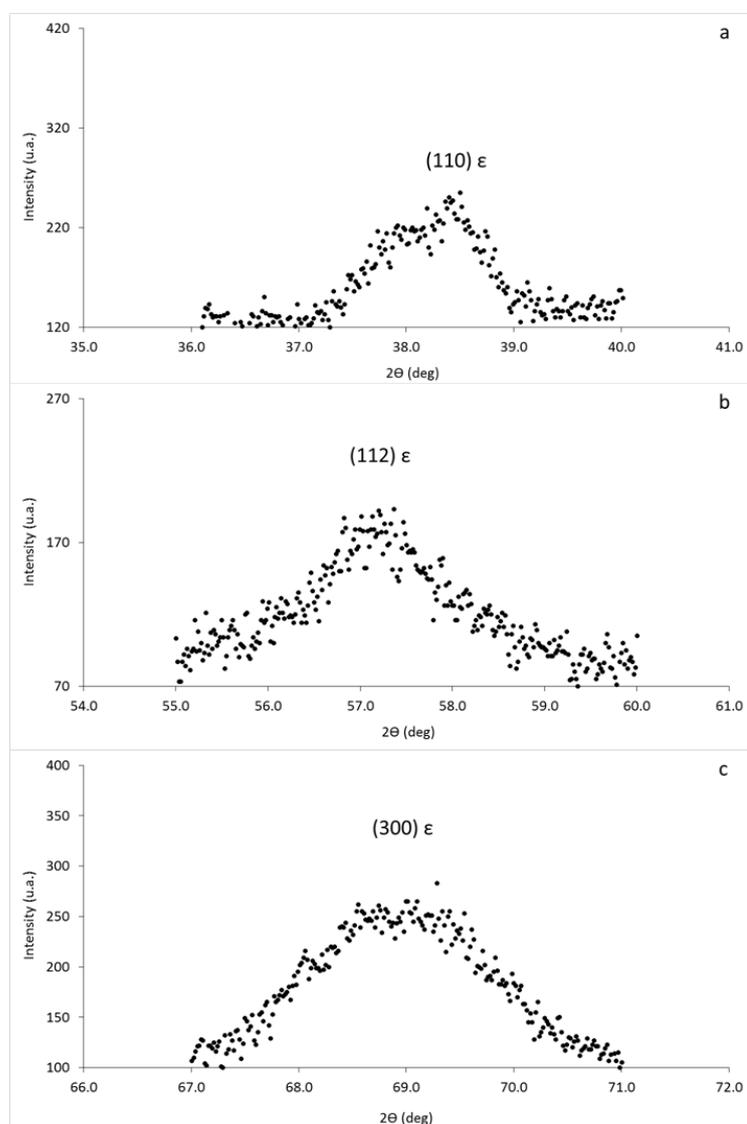
Figure 144: Some ϵ -nitride (Fe_3N) peaks obtained from the X-Ray diffractogram LCT-USP 196-2453 of the textured surface in the condition after SPN. a) (110) ϵ -nitride peak. b) (112) ϵ -nitride peak. c) (300) ϵ -nitride peak.

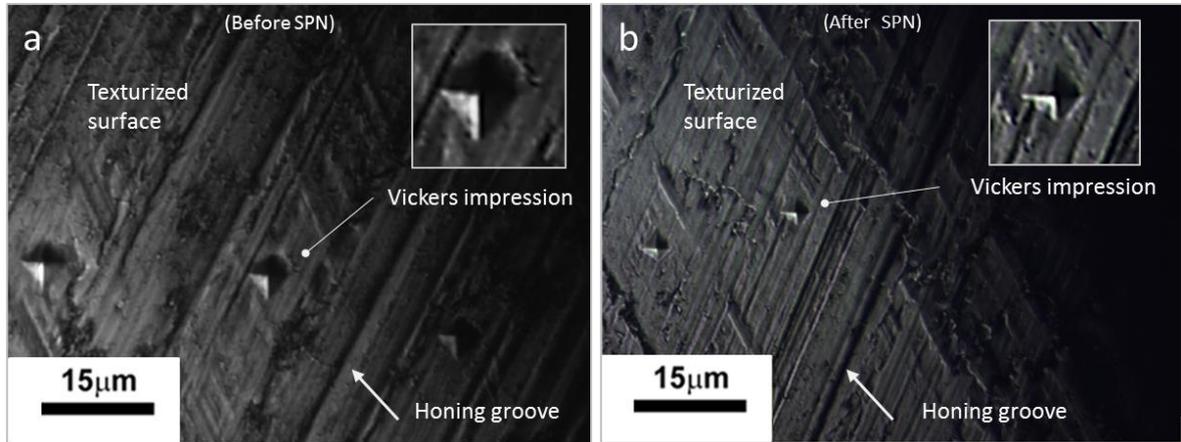
Figure 146: Dark-field optical microscopy images of the textured surface in condition before (a) and after (b) SPN, with respective Vickers (HV 0.01) indentations. Honing grooves of various dimensions are visible in both images.

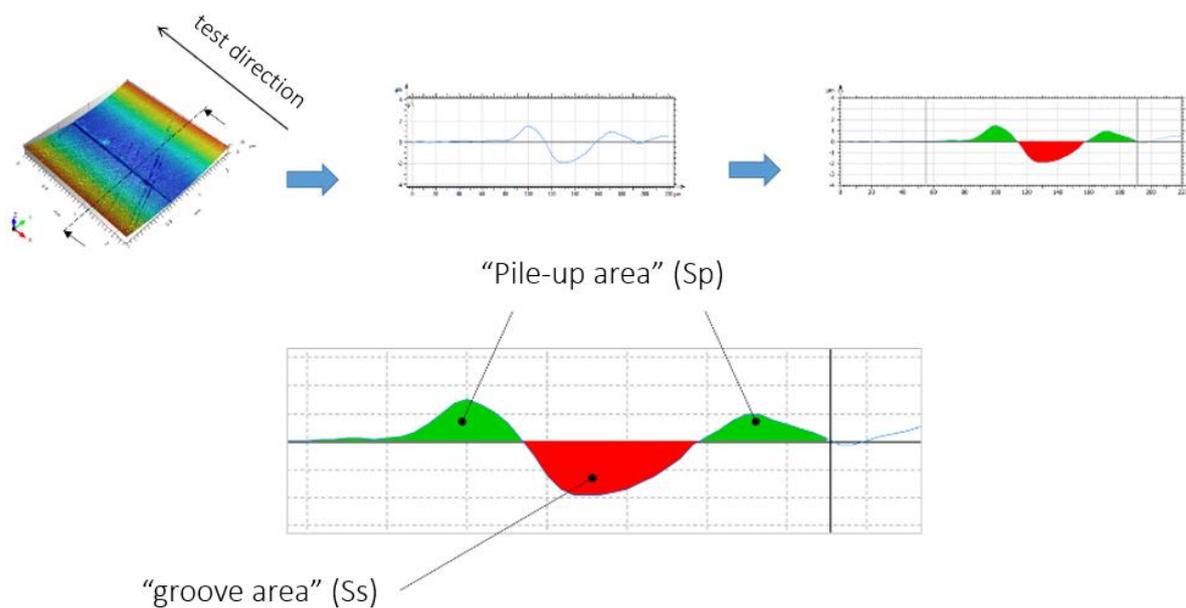
Figure 149: 2-D acquisition of Sp and Ss from the 3-D interference profile.

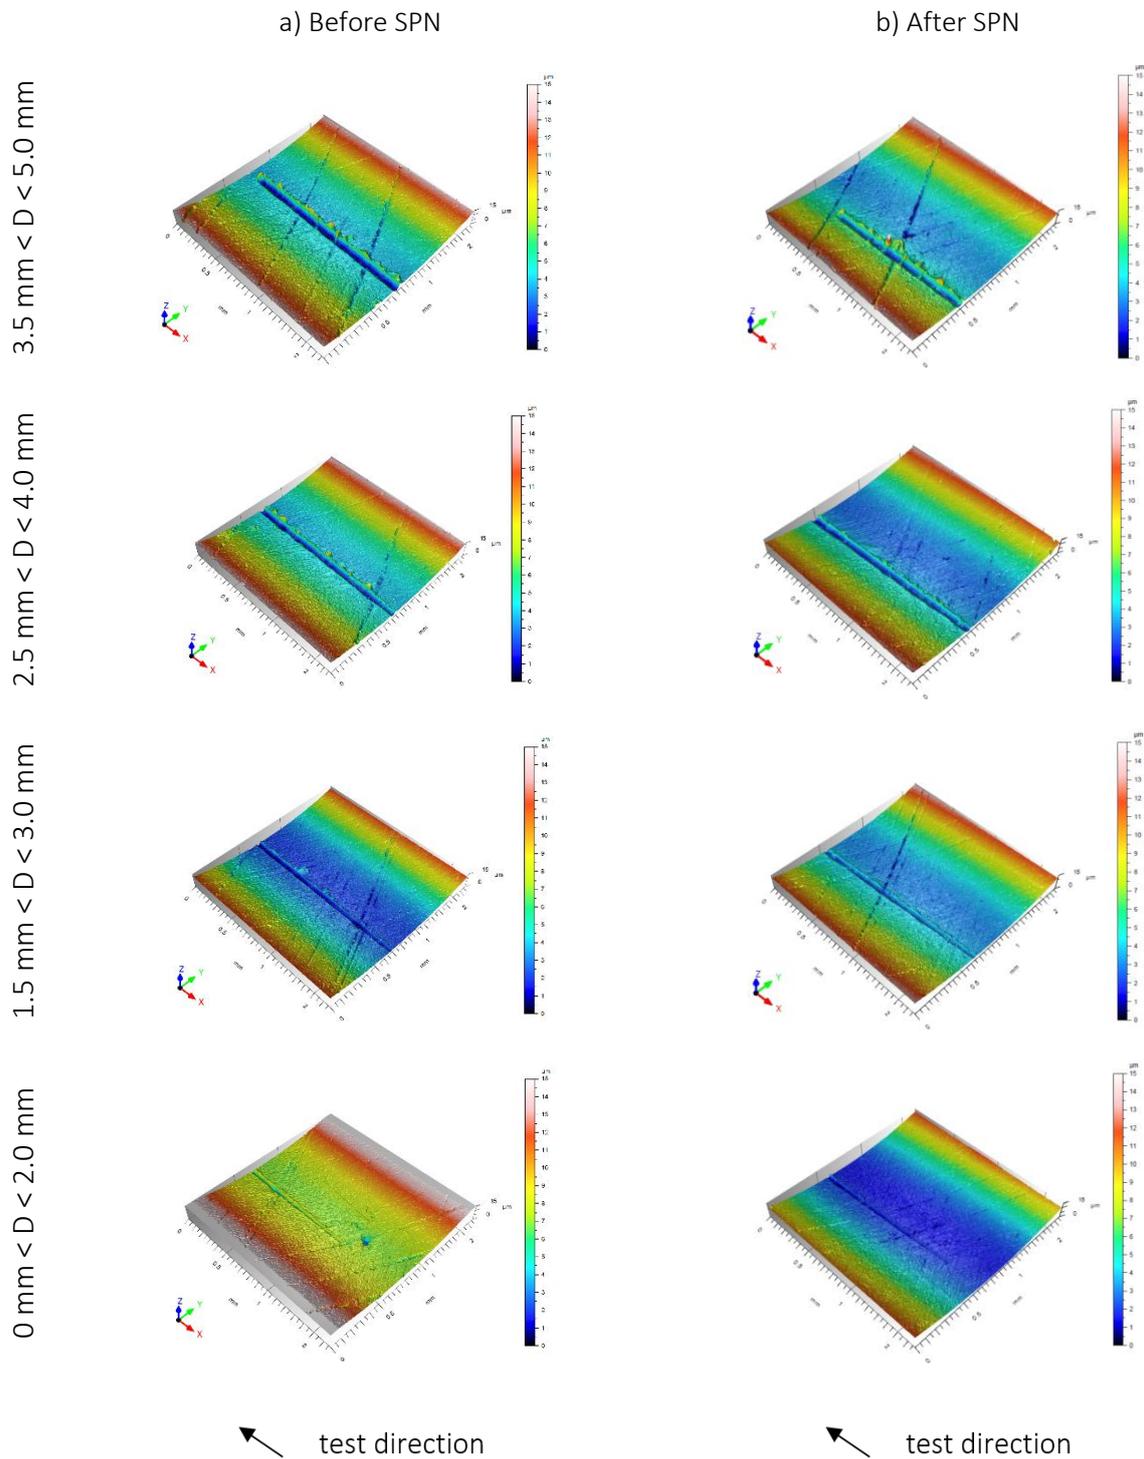
Figure 150: Progressive linear sclerometry test. Top [tilted] view of the 3-D profile of the surface in conditions before (CS-Raw) and after SPN treatment (CS-C350h2). Case-Study: As-honed surface specimen. Pre-load: 1 N / 10 s, linear increasing load: 1-10 N, 0.028 mm/s. Resulting scratch: 5 mm in length. Color scale indicates heights from valley to peak (primary form not filtered). Profiles at different distance ranges, highlighting the progressive evolution of the sclerometry groove. Honing texture preserved after SPN. Similar scratch appearance between the two conditions, with apparent higher level of plastic flowed (pile-up) material in condition before SPN.
